Original Article

COLREGs misunderstood or ignored?

ABSTRACT

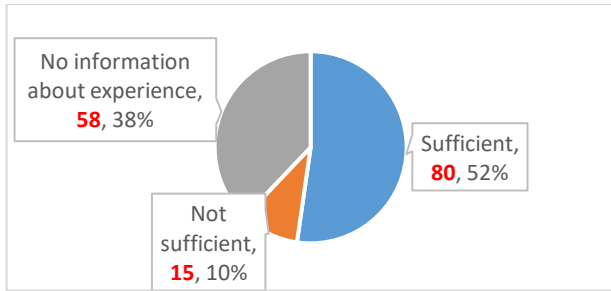
Figure 1 Experience of OOWs

In the graph below, experience is considered sufficient if the OOW had acquired at least 12 months

of sea experience in the capacity of OOW after obtaining the first Certificate of Competency (COC).

When analysing the available facts, 52% of the OOWs involved were found to have sufficiently experienced. However, most scholarly articles state that a high number of collisions occur due to lack of experience of the OOWs. This may have changed over the past few decades due to the implementation of the ISM Code, STCW Code, efforts of the ship management companies and the efforts of the countries engaged in training of seafarers.

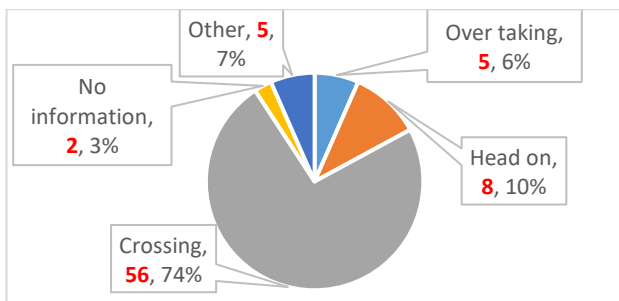
Figure 2 Situations that led to collisions

A very high number of accidents have occurred during crossing situations. Even though it was not evident from the casualty investigation reports, the reason could be that the probability of encountering crossing situations is higher than other situations, rather than misunderstanding or

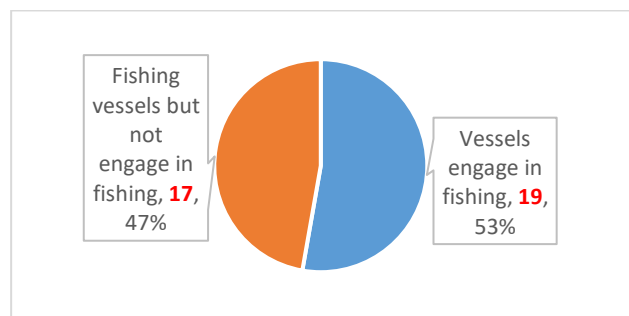
Figure 3 Collisions between cargo ships and fishing vessels

There is no appreciable difference of collisions between cargo ships and vessels engaged in fishing or not engaged in fishing. Further in accordance with the accident investigation reports there were no occasions where the lights and shapes were misunderstood by the OOWs of the cargo vessels.

During the period considered, 36 fishing vessels were damaged or foundered after 35 collisions encountered with cargo ships. 143 fishermen had died or were declared missing. When considering fishing vessels, application of COLREG differs, depending on whether they were engaged in fishing or not. Therefore, it is important to identify with certainty whether these vessels were engaged in fishing or not at the time of collision, as it is otherwise to be construed as a collision between two power driven vessels.

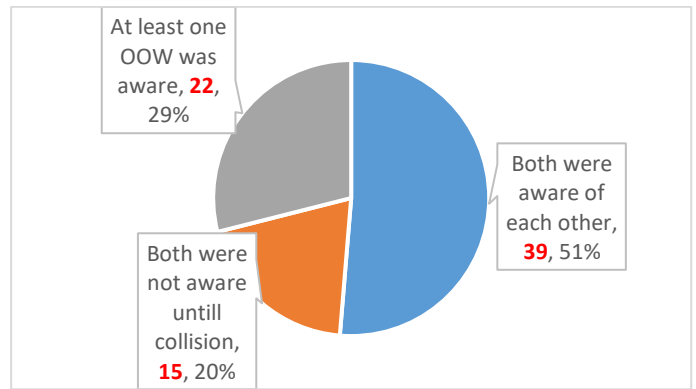
Figure 4 Awareness of the presence of the other vessel before the collision

In the graph below, ‘Aware’ means the OOW was aware of the presence of the other vessel with sufficient time to take action to avoid collision.

Only 20% accidents had taken place without the knowledge of both vessels involved. Which means the remaining 80% could have been avoided since at least one OOW was aware of the presence of the other vessel, provided the OOW correctly followed the COLREGs.

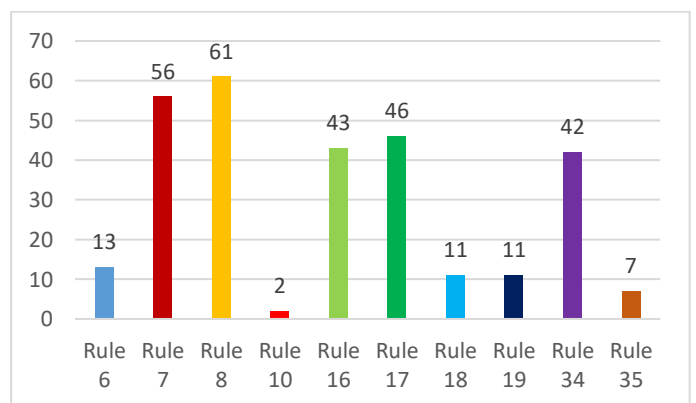
Figure 5 Breach by rule number

Below graph indicates breaches of Rules by the vessels involved in collisions other than Rule 13, Rule 14 and Rule 15 since they were discussed above.
