Guidance Manual for Tanker Structures

Consolidated Edition 2022

Tanker Structure Co-operative Forum

Consolidated text of 'Guidance Manual for Tanker Structures' incorporating IACS Recommendation No. 72: Confined Space Safe Practice – Rev.3 Dec 2018 and IACS Unified Requirements (UR) Survey and Certification: Z10.4 Hull Surveys of Double Hull Oil Tankers (Rev.16 May 2019).

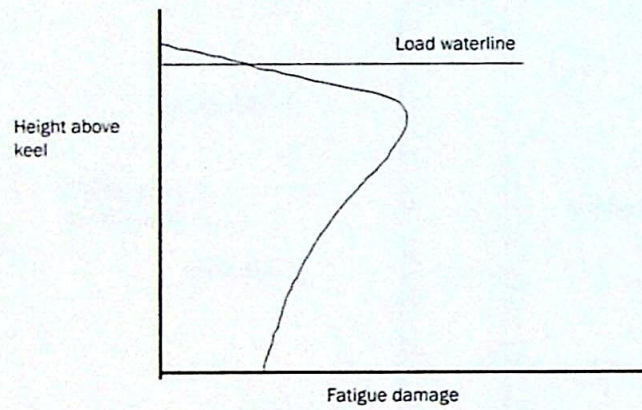
Typical Connections Between Longitudinals and Transverse Web or Bulkhead

Distribution of Fatigue Damage From Wave Loading Over Depth of Vessel

Figure 1.3: Typical Fatigue Damage Locations and Distribution

Deck, bottom and side shell connection of a longitudinal stiffener to a transverse web or bulkhead are shown in Figure 1.3. Of these locations the side shell is the most sensitive due to the combined actions of all three loading mechanisms with the addition of horizontal bending.

The effects of hydrodynamic pressure variations within the wave are most significant just below the load waterline. This results in a distribution of fatigue damage, as shown in Figure 1.3.

The above factors have to be considered when designs of HTS are made, and today it is normal practice to improve the detail design to reduce the stress concentrations in areas where calculations show that high dynamic stress levels are expected. Figure 1.3 indicates where the higher dynamic stress levels are found. The ship side is particularly prone.

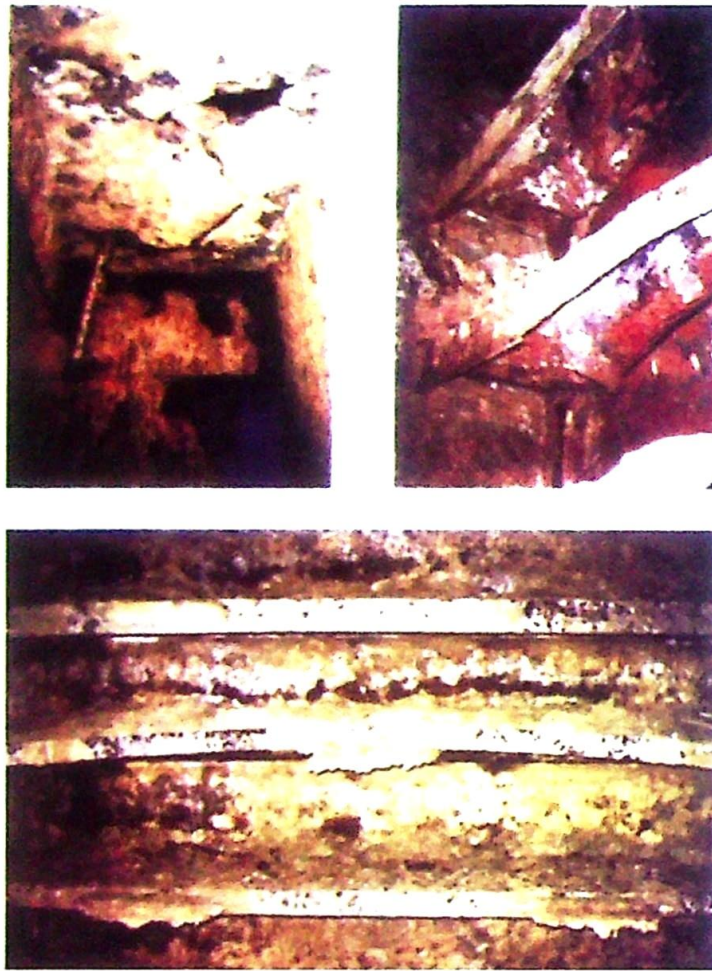
Figure 1.7: Corrosion of Longitudinal Bulkhead Longitudinal Stiffeners, Uncoated Segregated Ballast Tank

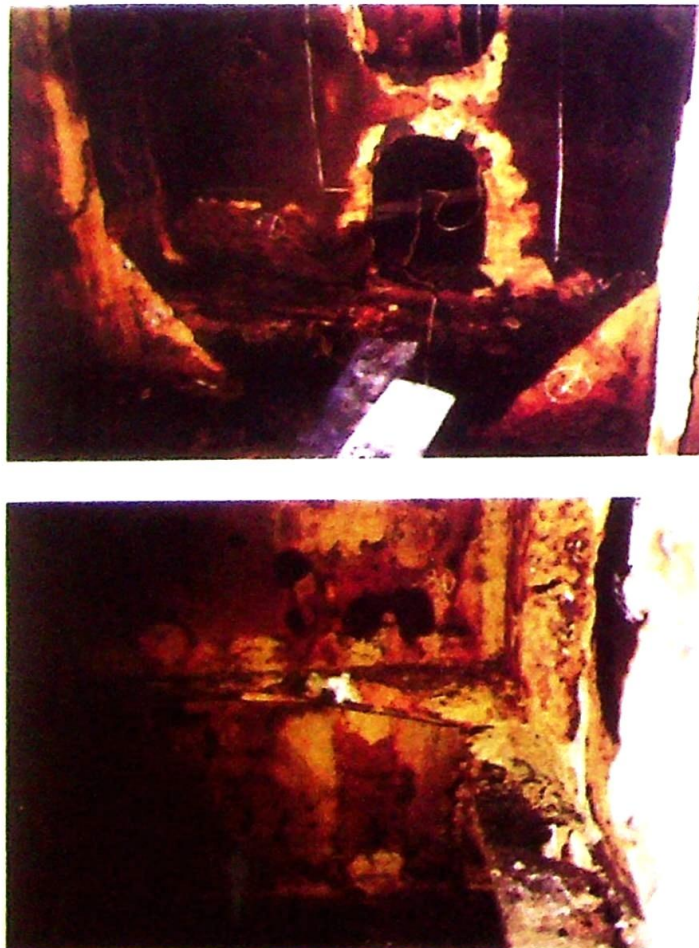
Figure 1.8: Local Corrosion in Way of Coating Failure, Coated Segregated Ballast Tank

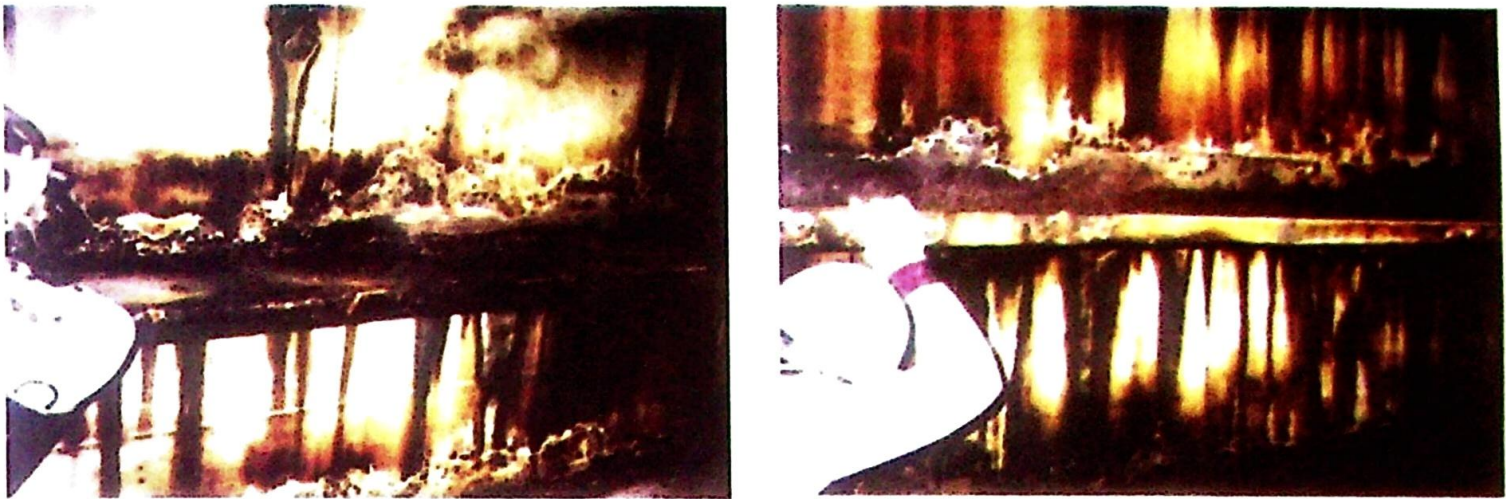
Figure 1.9: Corrosion of Longitudinal Bulkhead, Coated Segregated Ballast Tank

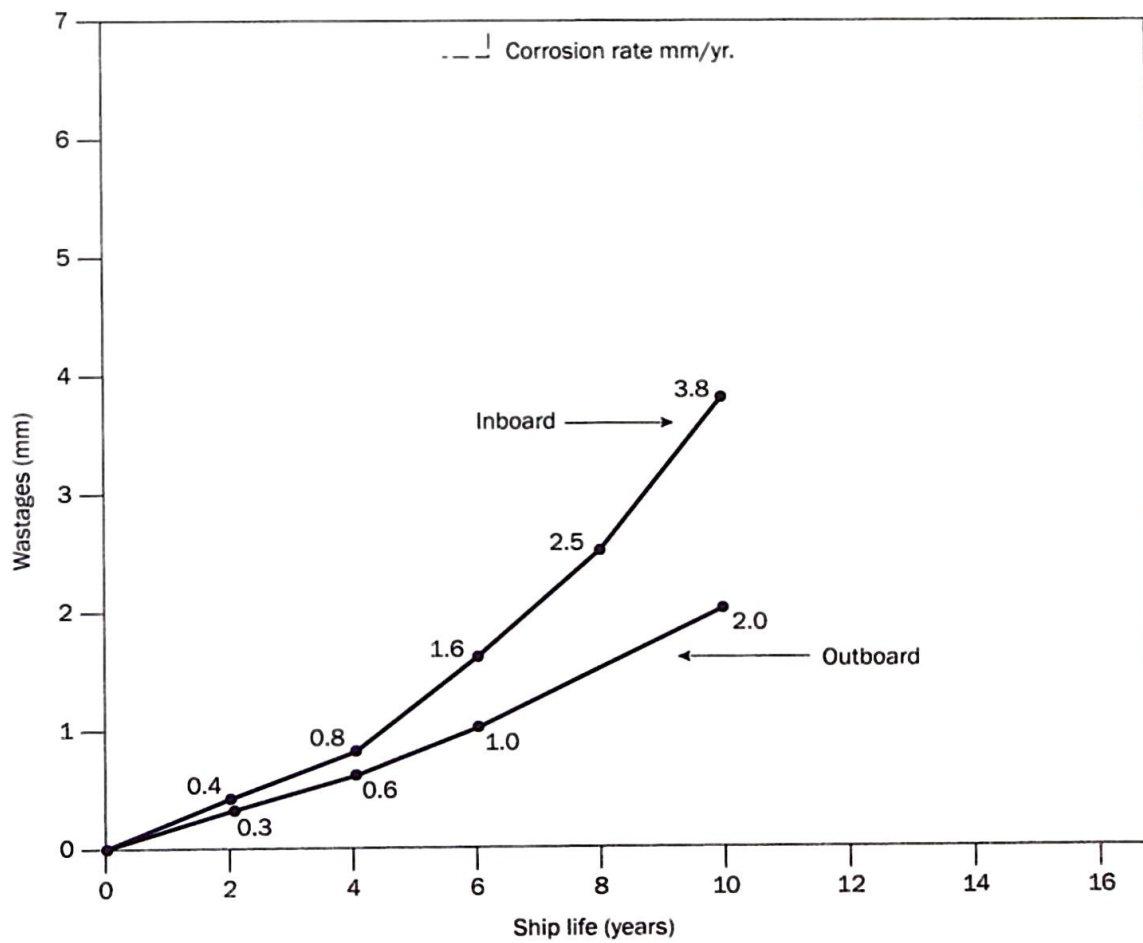
Figure 1.10: Accelerated Corrosion, Uncoated Segregated Ballast Tank

The vertical girders on the longitudinal bulkhead and the horizontal cross ties in the web frames are subjected to higher shear stress and have a higher corrosion rate in the uncoated water ballast tank (see Figure 1.10).

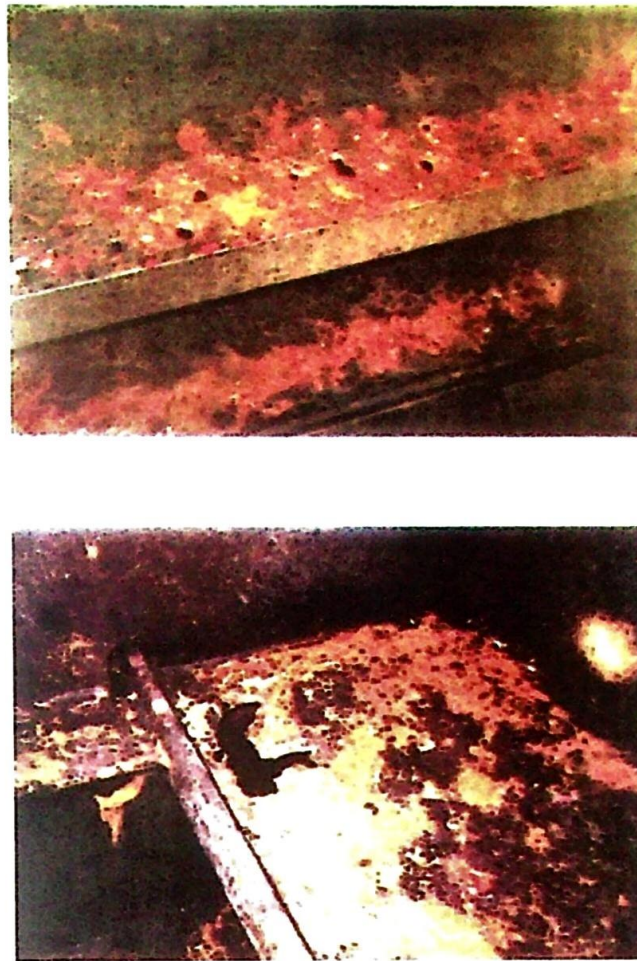
Figure 1.13: Corrosion of Side Shell Longitudinal (Uncoated Cargo/Departure Ballast Tank)

Sacrificial anodes can provide a very effective cathodic protection system in the cargo/arrival ballast tanks and decelerate the corrosion rate substantially provided that the system is installed and maintained at an adequate current density (see Figure 1.13).

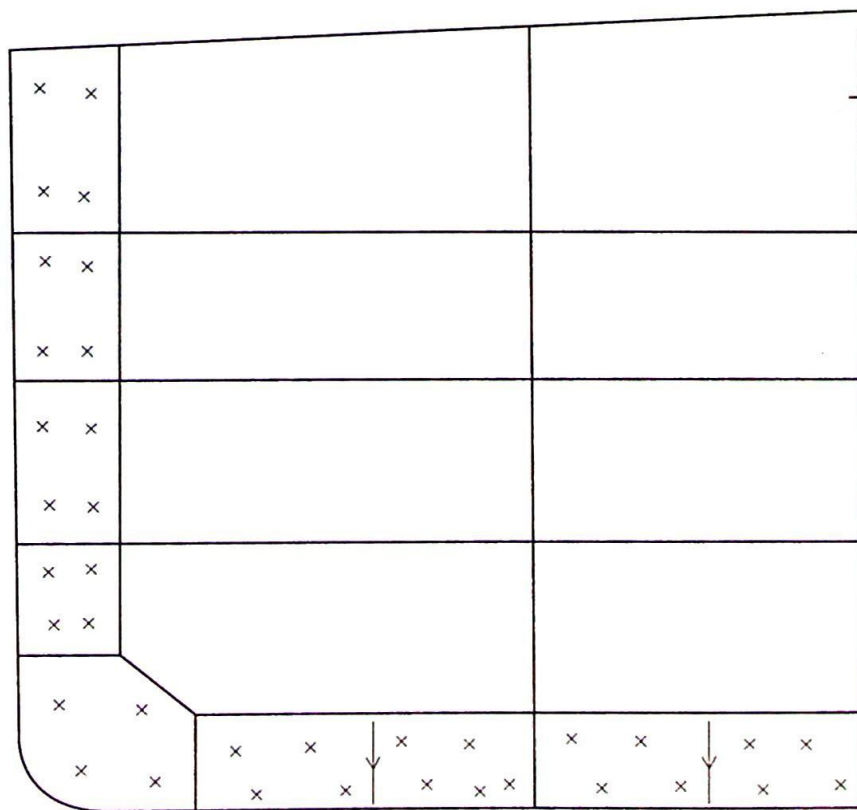
Figure 8: Transverse bulkheads in ballast tanks

Transverse rings (#) in cargo and ballast tanks	At least two points on each plate in a staggered pattern and two points on the corresponding flange where applicable. Minimum four points on the first plate below deck. Additional points in way of curved parts. At least one point on each of two stiffeners between stringers/ longitudinal girders.	Figure 6
Transverse bulkheads in cargo tanks	At least two points on each plate. Minimum 4 points on the first plate below main deck. At least one point on every third stiffener to be taken between each stringer. At least two points on each plate of stringers and girders, and two points on the corresponding flange. Additional points in way of curved part. Two points of each diaphragm plate of stools if fitted.	Figure 7
Transverse bulkheads in ballast tanks	At least 4 points on plates between stringers/ longitudinal girders, or per plate if stringers/girders not fitted. At least two points on each plate of stringers and girders and two points on the corresponding flange. Additional points in way of curved part. At least one point on two stiffeners between each stringer/longitudinal girder.	Figure 8

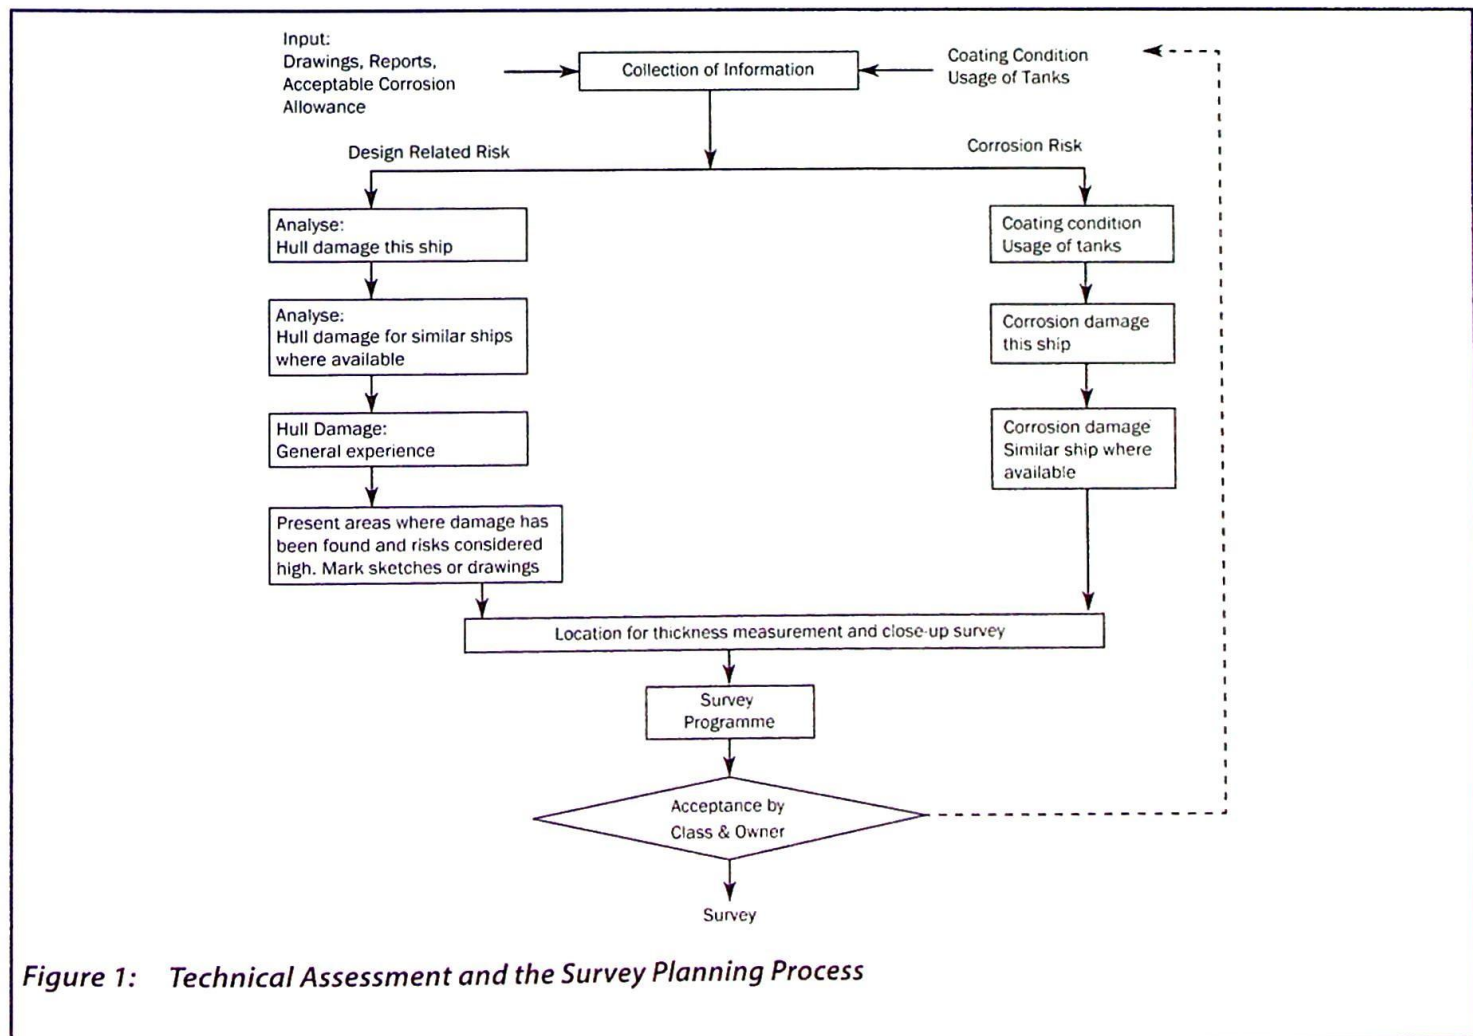
Figure 1: Technical Assessment and the Survey Planning Process

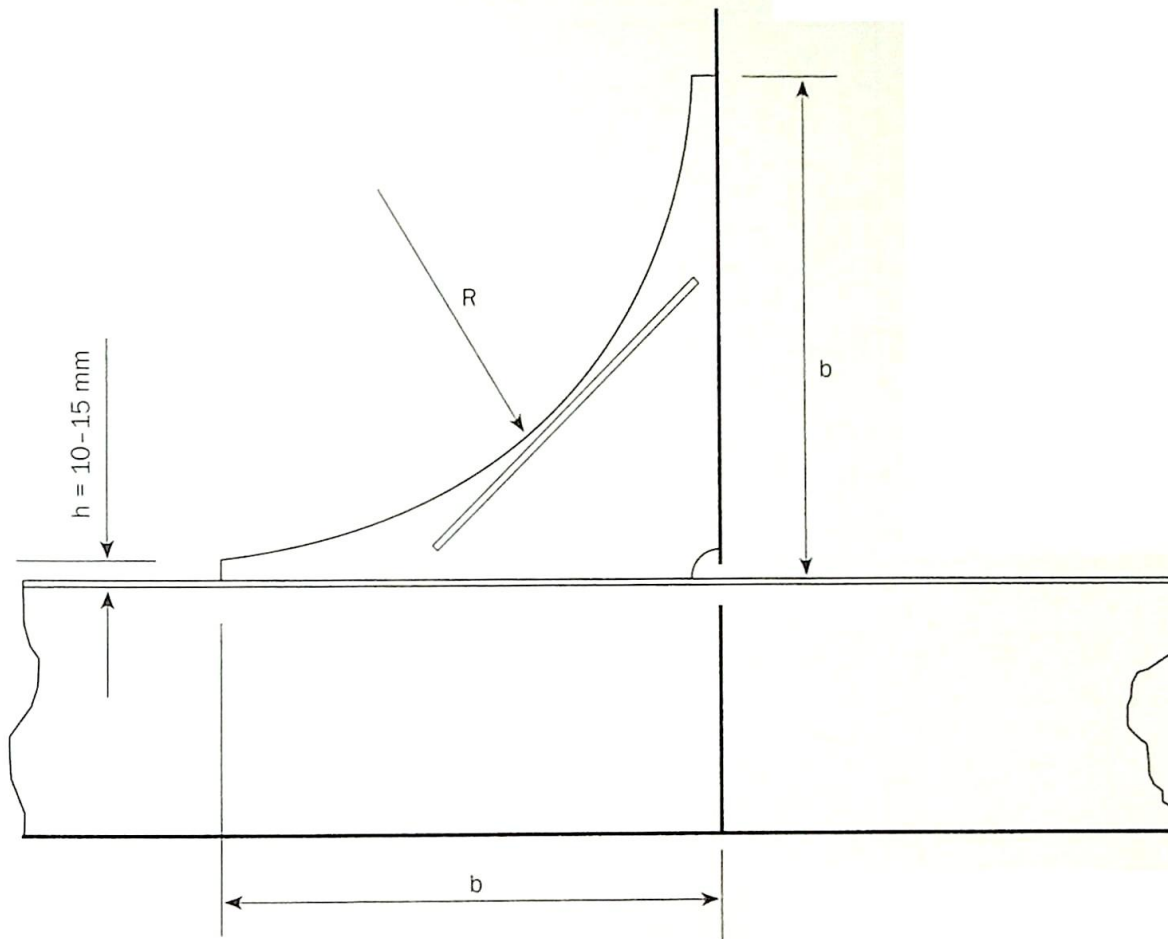
Detail type: Connection Bracket/Reverse Side of Tripping Bracket

Recommended Design

1. For a slope at toes max. 1:3, $R = (b - h) \times 1.6$.
2. Soft toe bracket to be welded first to longitudinal.
3. Scallop in bracket to be as small as possible, recommended max. 35 mm.
4. If toes of brackets are ground smooth, full penetration welds in way to be provided.
5. Toe height to be as small as possible (10–15 mm).
6. Maximum length/thickness ratio of unsupported bracket edge 50:1. Edge stiffener to be sniped.

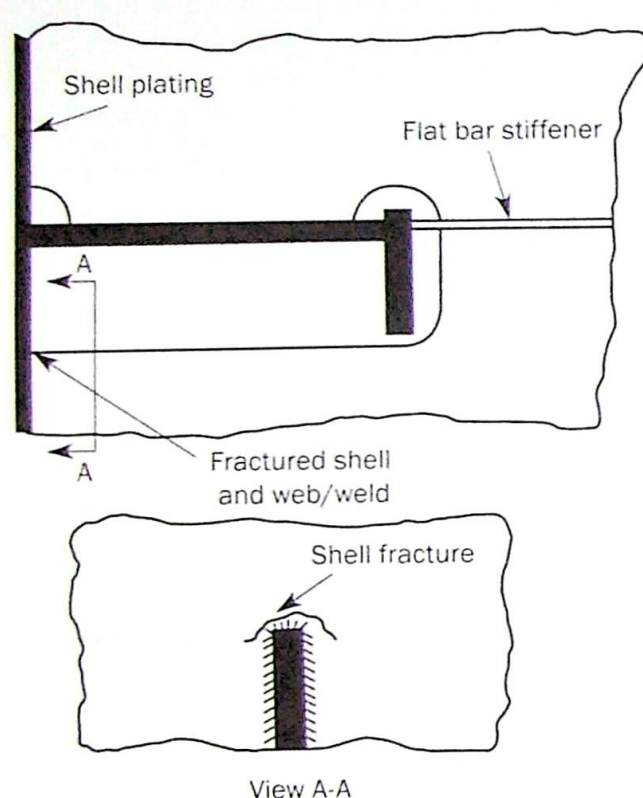
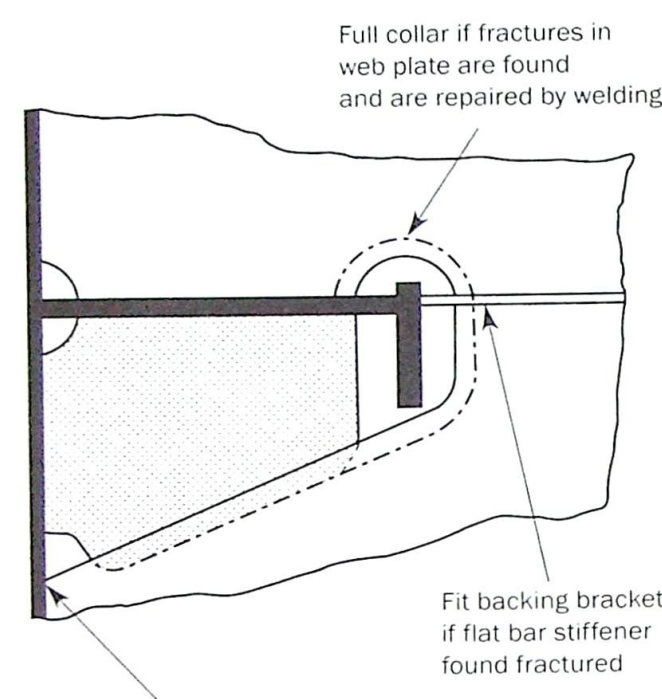
<p>Figure 2: 2 of 12</p>	<p>Catalogue of Structural Details</p>

<p>GROUP No. 1 (Refer to index on Page 178)</p>	<p>Location: Connection of Longitudinals to Transverse Webs</p> <p>Example No. 2: Side Shell Fractures at Cut-outs for Longitudinal Stiffener Connections</p>	
	<p>Typical Damage</p>	<p>Proposed Repair</p>

<p>Note: Fractures initiate at inner surface of shell and propagate through to outer surface</p>

<p>Shell plate cropped and part renewed. Alternatively where fractures are small they may be repaired by welding (see additional notes under 'alternative repairs', 2.3)</p>	
<p>FACTORS CONTRIBUTING TO DAMAGE</p> <ol style="list-style-type: none"> 1. Insufficient area of connection of longitudinal to web plates. 2. Defective weld at return around the plate thickness. 3. Localised corrosion associated with the stress concentrations in way of the longitudinal connection of web to shell. 4. Dynamic sea way loads/ship motions. 5. High shear stress in the transverse web.

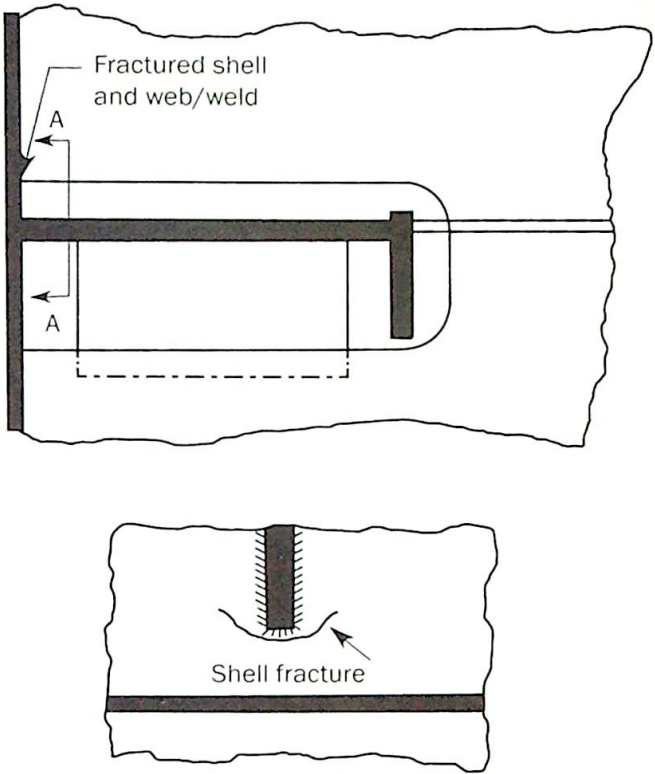
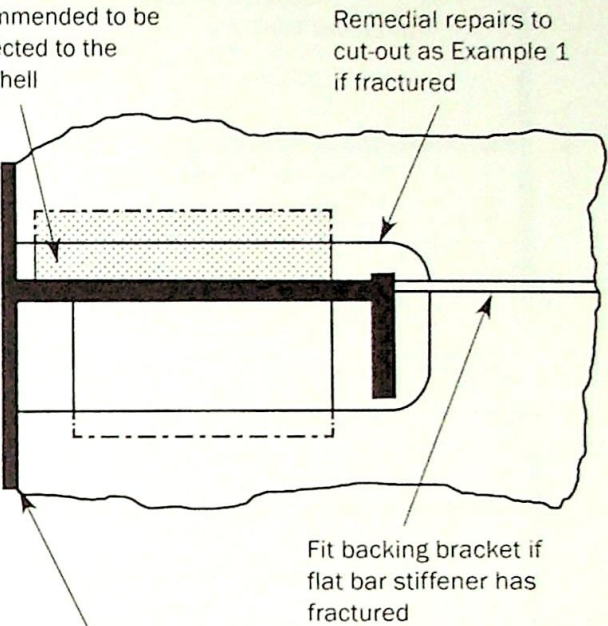
Figure 3: 3 of 12	Catalogue of Structural Details

GROUP No. 1 (Refer to index on Page 178)	Location: Connection of Longitudinals to Transverse Webs	
	Example No. 3: Side Shell Fractures as Example No. 2 but Due to Single Lug on Underside	
	Typical Damage	Proposed Repair

<p>Fractured shell and web/weld</p> <p>View A-A</p> <p>Shell fracture</p>

<p>Recommended to be connected to the side shell</p> <p>Remedial repairs to cut-out as Example 1 if fractured</p> <p>Fit backing bracket if flat bar stiffener has fractured</p> <p>Fractures in shell plating repaired by welding. Alternatively where fractures are large, shell plate may be cropped and part renewed</p>
	FACTORS CONTRIBUTING TO DAMAGE	
	<ol style="list-style-type: none"> 1. Single lug fitted into bosom of longitudinal (instead of at the heel side) resulting in greater deflections of the longitudinal due to dynamic loads and therefore higher stress at the upper edge of the cut-out adjacent to the shell. 2. Fracture in web flat bar stiffener connection resulting in greater deflection of longitudinal. 3. Defective weld at return around the plate thickness. 4. Dynamic sea way loads/ship motions.

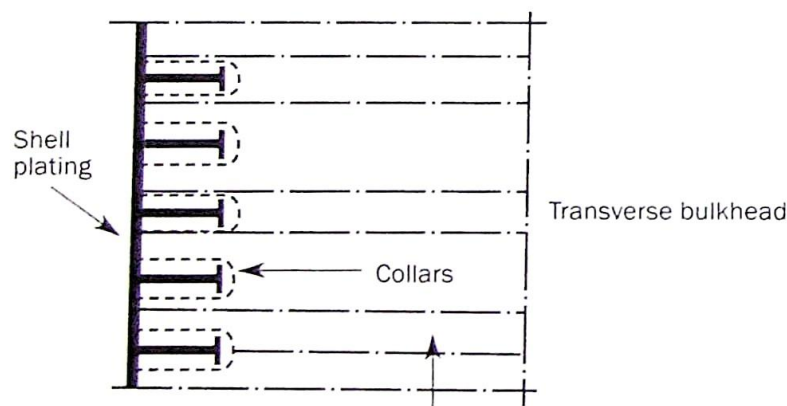
- 2.2 Add collar plates (closing plates) with 25% thickness increase around the longitudinals.

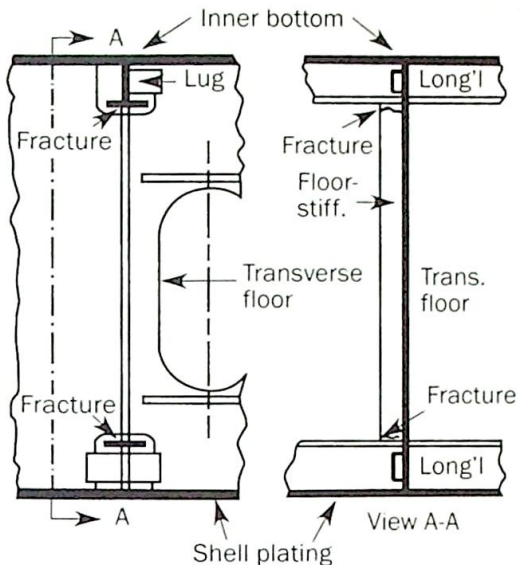
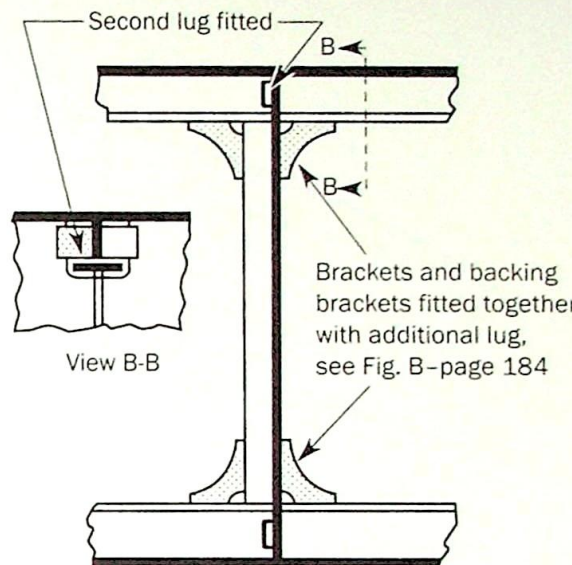
Figure 21: 1 of 1	Catalogue of Structural Details

GROUP No. 4 (Refer to index on Page 179)	Location: Connection of Longitudinals to Floors in the Double Bottom Example No. 1: Fractured Stiffener Connection to Bottom and Inner Bottom Longitudinals
<p style="text-align: center;">Typical Damage</p>

<p style="text-align: center;">Proposed Repair</p>

<p>FACTORS CONTRIBUTING TO DAMAGE</p> <ol style="list-style-type: none"> Asymmetric connection leading to high local stresses at the connection of vertical stiffeners of the transverse floors to the inner and outer bottom longitudinals. Wide slot for longitudinal leads to inefficient lug connection. Sharp corners or flame-cut edges producing a notch effect. Incomplete/defective weld at stiffener connection to the longitudinals. Dynamic sea way loads/ship motions. 	
<p>Additional Notes</p>	
<ol style="list-style-type: none"> REPAIR NOTES <ol style="list-style-type: none"> Where fractures in the toe of the stiffeners follow the line of weld to the longitudinal, repair by arc gouging to beyond end of crack and rewelding will be required. In case of larger fractures into the parent material of the stiffener, the material will be either cropped and part renewed or renewed completely. Particular attention should be paid to the welding at the stiffener. Additional lugs should be added similar to group 1 repairs. Brackets of equal thickness to the vertical stiffener will be required between the longitudinal and transverse floor in the same plane as the floor stiffening. All edges must be ground smooth including the scallop cut-outs. ALTERNATIVE REPAIRS None known. UNSUCCESSFUL REPAIRS <ol style="list-style-type: none"> Rewelding of cracks without reinforcement brackets may lead to a rapid re-occurrence of fractures. Fittings of a single large bracket to the transverse floor and longitudinal on the side opposite to the vertical stiffener may lead to a migration of the region of high stress to the opposite edge of the stiffener toe connection to the longitudinal. Single brackets fitted on the side of the vertical stiffener will reduce the stress peaks but fatigue fractures may still occur, particularly at the heel of the flat bar stiffener. A vertical single lug connecting the longitudinal to the transverse floor does not reduce the high stress concentration sufficiently in view of the wide slot on this arrangement. NEW CONSTRUCTION <ol style="list-style-type: none"> Provide double lugs for all inner bottom and bottom connections of floors to longitudinals. Cut-outs for longitudinals in floors should be kept as small as possible. Ensure flat bar stiffening provides a good connection onto the longitudinals. Alternatively, consider adopting brackets with ground cut-outs and generous radii.

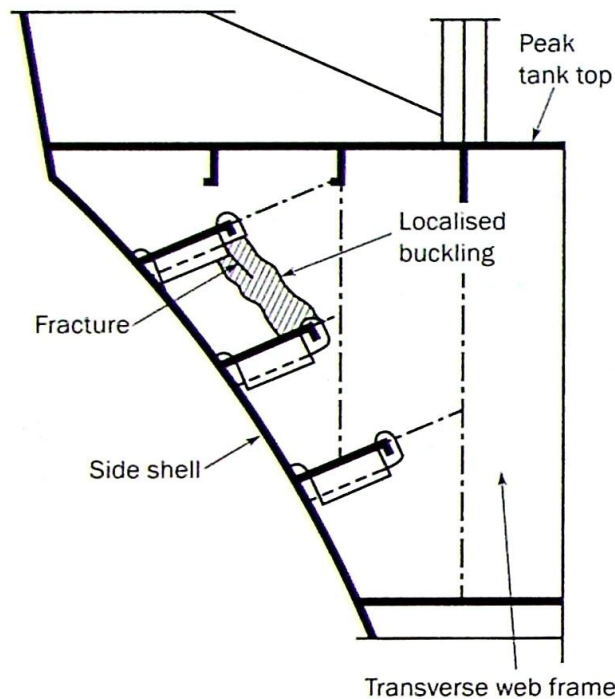
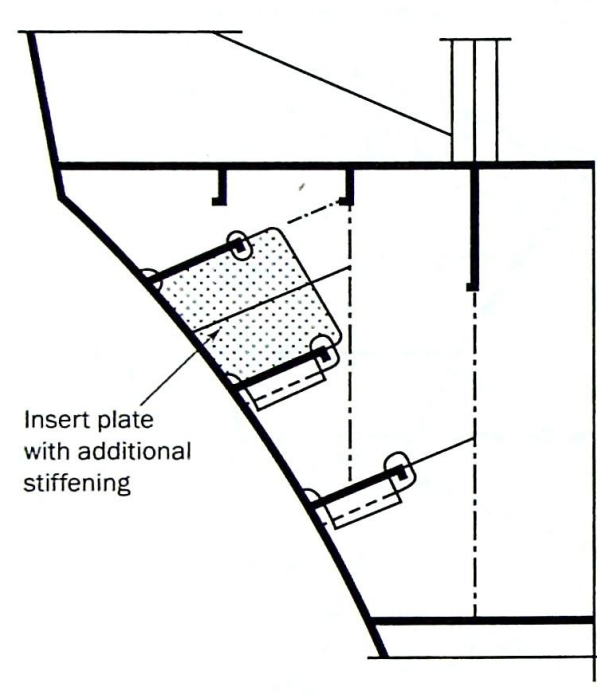
<p>Figure 26: 5 of 6</p>	<p>Catalogue of Structural Details</p>

<p>GROUP No. 5 (Refer to index on Page 179)</p>	<p>Location: Fore Peak Structure Example No. 5: Fractured and Buckled Bow Transverse Web Frame in Way of Longitudinal Cut-outs</p>
<p style="text-align: center;">Typical Damage</p>

<p style="text-align: center;">Proposed Repair</p>

<p>FACTORS CONTRIBUTING TO DAMAGE</p> <ol style="list-style-type: none"> 1. Localised thinning in way of coating failure at cut-outs and sharp edges due to working of the structure. 2. Dynamic seaway loadings in way of bow flair. 	
<p style="text-align: center;">Additional Notes</p>	
<p>3. UNSUCCESSFUL REPAIRS</p> <ol style="list-style-type: none"> 3.1 Gouging and welding of the fractures without the indicated modifications may lead to re-occurrences of the fractures. 3.2 Gouging and welding of the fractures instead of plate renewal, even with the indicated modifications, will provide improved performance but re-occurrences of the fractures can be expected due to additional stress concentrations in way of the weld-up.

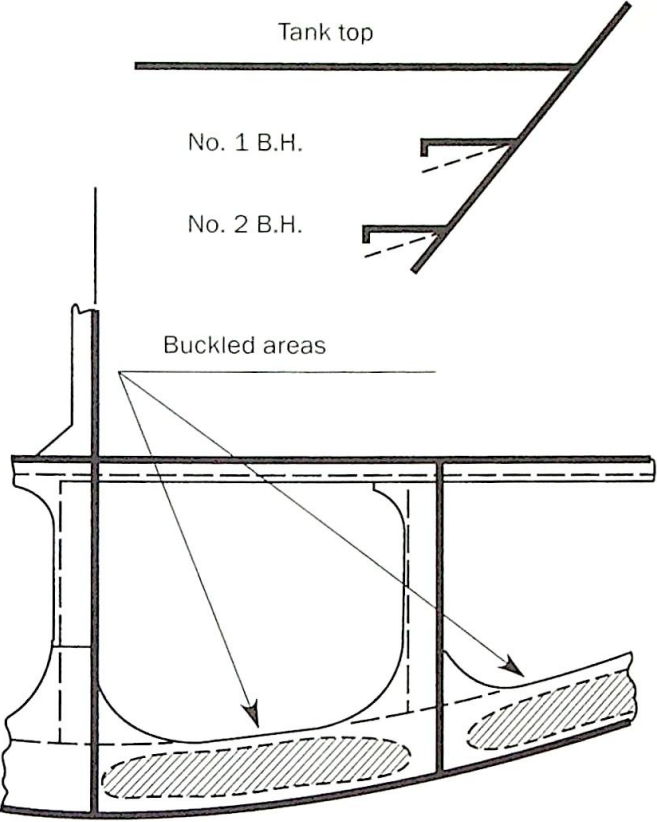
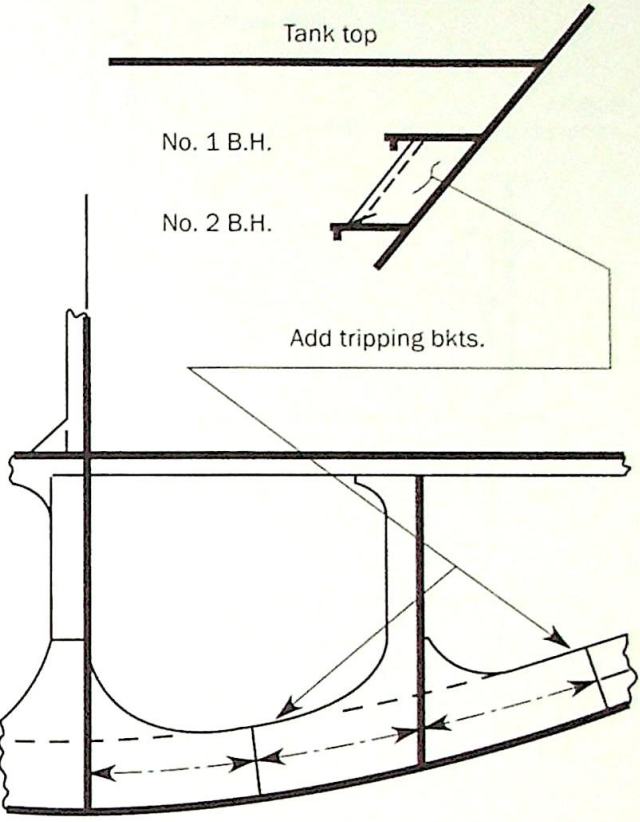
Figure 27: 6 of 6	Catalogue of Structural Details

GROUP No. 5 (Refer to index on Page 179)	Location: Fore Peak Structure Example No. 6: Buckled and Tripped Breasthooks	
Typical Damage		Proposed Repair

FACTORS CONTRIBUTING TO DAMAGE <ol style="list-style-type: none"> 1. Bow impact load. 2. Low buckling resistance. 		
Additional Notes		
<ol style="list-style-type: none"> 4. NEW CONSTRUCTION <ol style="list-style-type: none"> 4.1 For Example No. 1, provide adequate support for the bracket endings. 4.2 For Example No. 2, avoid ending face plates short of web plating at the intersections of stiff girders and deep webs and ensure a proper bracketed ending is provided to the stringers. 4.3 For Examples Nos. 3 and 4, provide adequate soft nose bracket endings with a face plate taper of at least 1:3. 4.4 For Example No. 5, provide sufficient attachment and web panel stiffening to absorb dynamic loads enhanced by bow flare shape. 4.5 For Example No. 6, provide tripping brackets at mid-span of breasthook webs and additional stiffening. 4.6 Dimensioning of diaphragm plates in bow to be specially considered on basis of dynamic loading and adequate support of longitudinals.

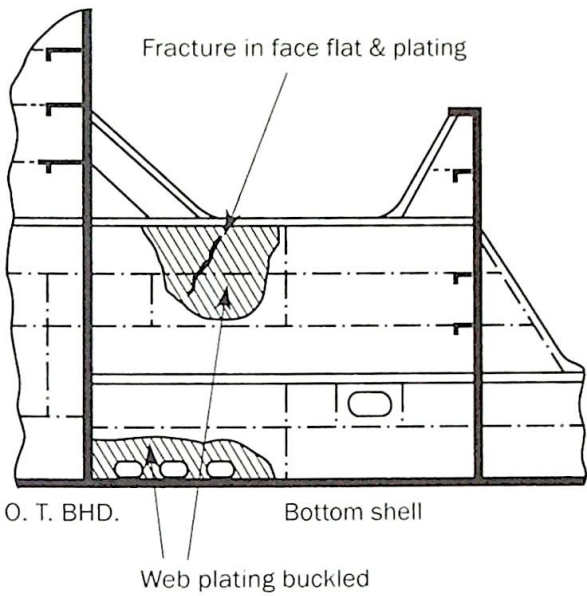
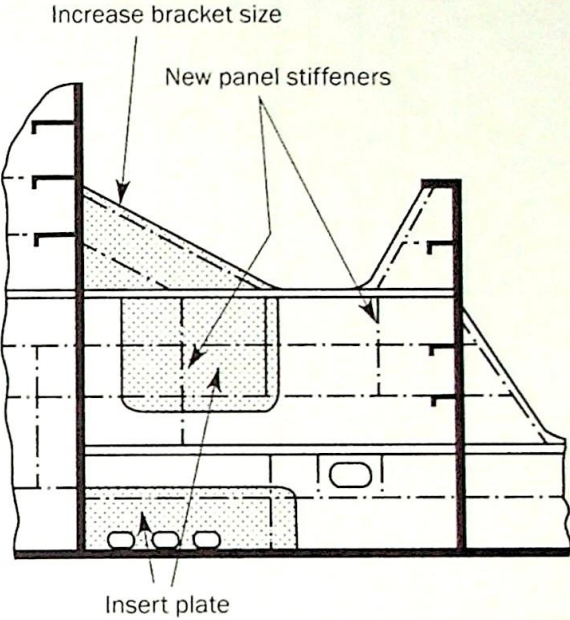
Figure 29: 2 of 7	Catalogue of Structural Details

GROUP No. 6 (Refer to index on Page 179)	Location: Longitudinal Girder End Brackets Example No. 2: Fractured and Buckled Buttress in Way of Bracket Connection to O.T. Bulkhead	
	<i>Typical Damage</i>	<i>Proposed Repair</i>

FACTORS CONTRIBUTING TO DAMAGE <ol style="list-style-type: none"> 1. Panel stiffening on girder web not fitted in way of bracket toe. 2. Stress concentration at bracket toe. 3. Local drydocking loads. 		
<i>Additional Notes</i>		
<p>3. UNSUCCESSFUL REPAIRS</p> <ol style="list-style-type: none"> 3.1 Doubler plate in lieu of insert plate at face plate under toe of bracket. 3.2 Inserts or doubler plates without modification to bracket to reduce stress concentration effect. <p>4. NEW CONSTRUCTION</p> <ol style="list-style-type: none"> 4.1 Minimise stress concentration by gradual change in section of primary members. 4.2 Avoid abrupt bracket toe ending and provide face plate tapers of at least 1:3. 4.3 Compensation for holes by insert of increased thickness plate in the web or longitudinal.

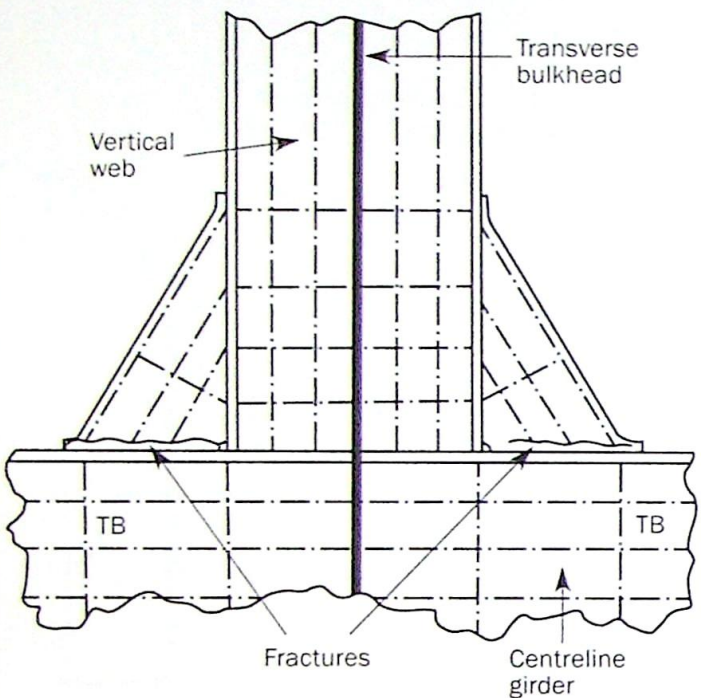
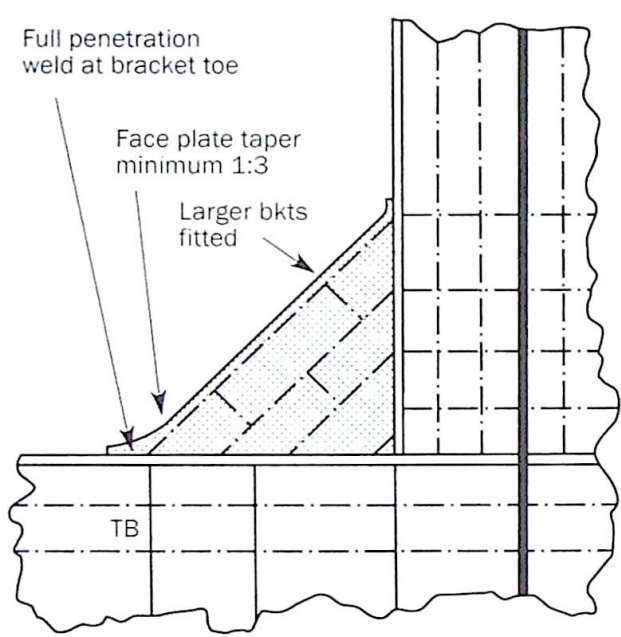
<p>Figure 30: 3 of 7</p>	<p>Catalogue of Structural Details</p>

<p>GROUP No. 6 (Refer to index on Page 179)</p>	<p>Location: Longitudinal Girder End Brackets</p> <p>Example No. 3: Fractured Vertical Web Bracket Connection to Bottom Centreline Girder</p>	
<p>Typical Damage</p>		<p>Proposed Repair</p>

<p style="text-align: right;">See Fig. F-page 188</p>
<p>FACTORS CONTRIBUTING TO DAMAGE</p> <ol style="list-style-type: none"> 1. Inadequate end bracket to vertical web resulting in high nominal stress. 2. Bracket toe having inadequate taper resulting in stress concentration. 3. Insufficient buckling strength of the bracket face plate. 		
<p style="text-align: center;">Additional Notes</p>		
<ol style="list-style-type: none"> 1. REPAIR NOTES <ol style="list-style-type: none"> 1.1 Leg of bracket connecting to bottom girder should be extended to align with existing panel stiffening on bottom girder and incorporate a generous soft nose. Face plate taper should be at least 1:3. 1.2 Bracket toe to bottom girder face plate to be attached by full penetration weld. 1.3 Panel stiffening of bracket should be incorporated as necessary. Panel on girder immediately in way of new bracket toe should have an additional vertical stiffener fitted. 1.4 Size of face plate to be checked for buckling based on the increased span. 2. ALTERNATIVE REPAIRS <ol style="list-style-type: none"> 2.1 Sniped face plate of bracket may be cropped back and connected to girder face plate by full penetration welds. A vertical tripping bracket should then be fitted to the girder (see Example No. 4). 2.2 Bracket may be cropped back and part renewed to provide a larger bracket. 3. UNSUCCESSFUL REPAIRS <ol style="list-style-type: none"> 3.1 Toe of bracket cropped back and insert fitted without modification to bracket connection. 3.2 Fractures welded up without modification. 4. NEW CONSTRUCTION <ol style="list-style-type: none"> 4.1 Confirm bracket sizes by calculation. 4.2 Provide generous soft nose connection with face plate taper of at least 1:3.

- 2.1 For the fractures in the brackets, larger brackets may be fitted retaining the snipped face plate (see Example No. 3).

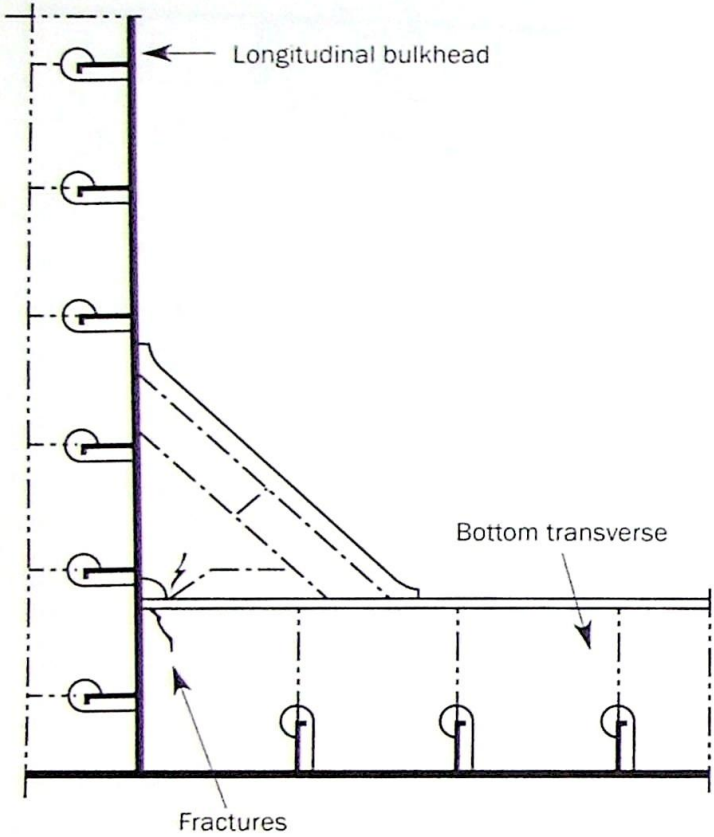
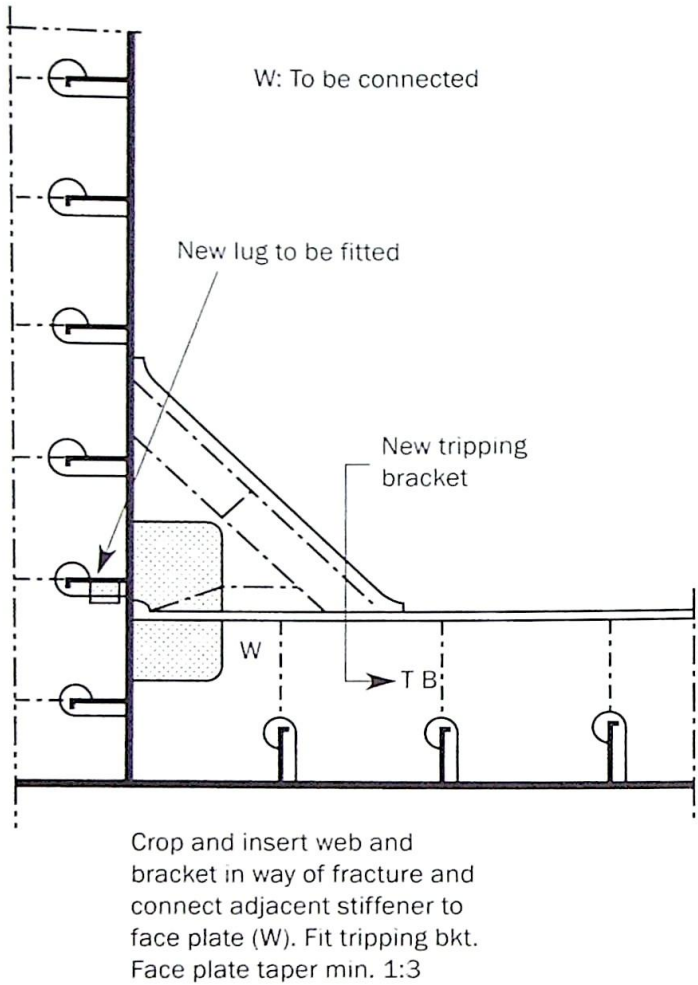
<p>GROUP No. 8 (Refer to index on Page 180)</p>	<p><i>Location: Primary Web Face Plate End Connection</i></p>	
<p><i>Example No. 2: Fractured Centre Tank Bottom Transverse</i></p>		
<p><i>Typical Damage</i></p>		<p><i>Proposed Repair</i></p>

<p>W: To be connected</p> <p>New lug to be fitted</p> <p>New tripping bracket</p> <p>W</p> <p>T B</p> <p>Crop and insert web and bracket in way of fracture and connect adjacent stiffener to face plate (W). Fit tripping bkt. Face plate taper min. 1:3</p>

1. Distance between longitudinal bulkhead and the bottom transverse tripping bracket too long.
2. Defective weld at the face plate taper.
3. Insufficient taper of the bottom transverse face plate.

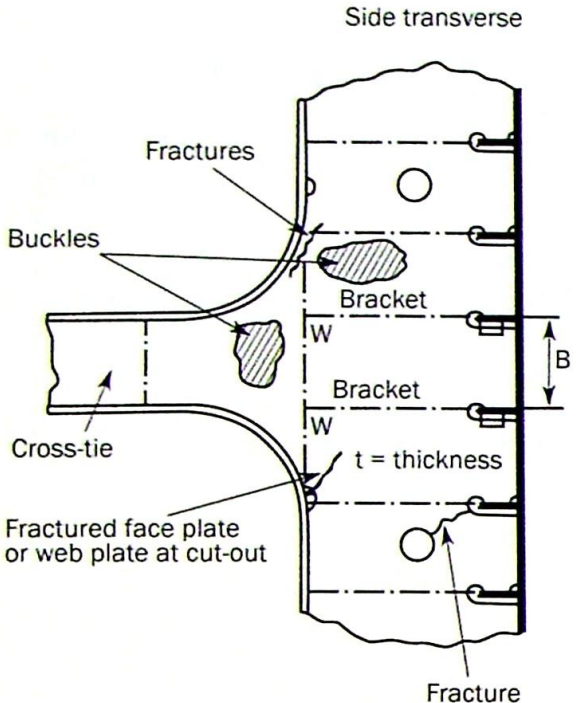
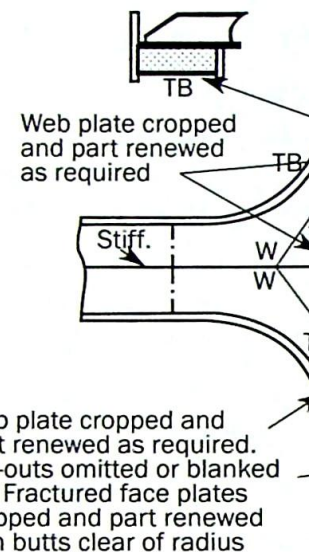
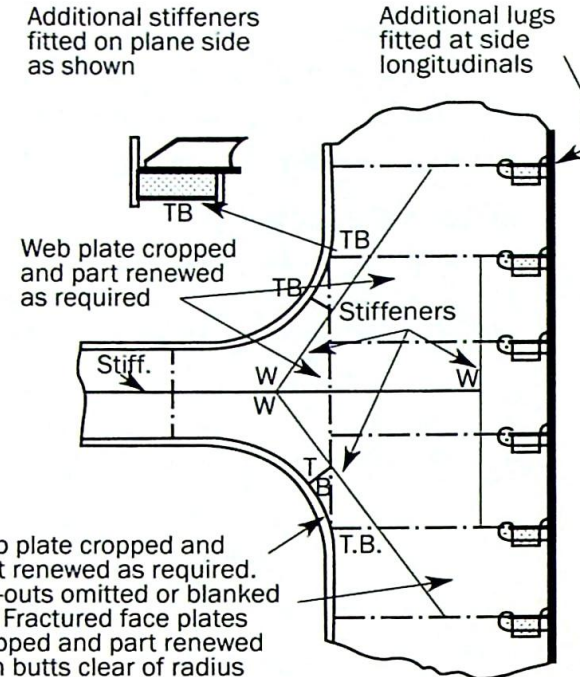
GROUP No. 9 (Refer to index on Page 180)	Location: Cross-ties and Their End Connections Example No. 1: Fractured and Buckled Web Plate and Fractured Face Plate
Typical Damage	Proposed Repair
<div style="text-align: center;">Side transverse</div>

<p style="text-align: center;">Note: Fractures & buckles not necessarily occurring together</p>	<div style="display: flex; justify-content: space-around;"> <div style="width: 45%;"> <p>Additional stiffeners fitted on plane side as shown</p>

</div> <div style="width: 45%;"> <p>Additional lugs fitted at side longitudinals</p>

</div> </div> <p style="text-align: center;">W: To be connected</p>
FACTORS CONTRIBUTING TO DAMAGE	
<ol style="list-style-type: none"> 1. Face plate radius in way of the cross-tie too small leading to high stress under bending of vertical web and cross-tie. 2. Stress concentration at notches in web plate. 3. Localised corrosion of web plate particularly in ballast tanks leading to panel flexing and fractures. 4. Inadequate panel stiffening of web plate.

Additional Notes	
<ol style="list-style-type: none"> 1. REPAIR NOTES 1.1 In cases where there are no fractures and only slight buckling that requires reinforcement, which should be fitted as indicated. 1.2 Where plating is fractured or requires renewal due to thinning over the full area, the following thickness guidance is given to ensure adequate panel buckling stability: <ol style="list-style-type: none"> a) When two or three cross-ties are fitted, the upper cross-tie and the centre cross-tie of three should have a panel breadth ratio B/t equal to or less than 60. b) The lower cross-tie of two or three or when only one is fitted should have a panel breadth ratio B/t equal to or less than 55. Where plating is renewed to these thicknesses, the additional stiffening shown can be omitted. 1.3 In cases where plating is not adversely affected by corrosion and fractures are isolated, then a repair by cropping and local insert plates could be made in way of the fracture. 1.4 Where transverse tripping brackets to cross-ties are not connected to face plates, opportunity should be taken to connect these brackets, whether or not fractures have occurred. 1.5 Lightening holes and notches in the vicinity of the cross-ties should be filled in. 1.6 Additional lugs should be attached to the side shell and longitudinal bulkhead longitudinals (see proposed repairs under Group 1).

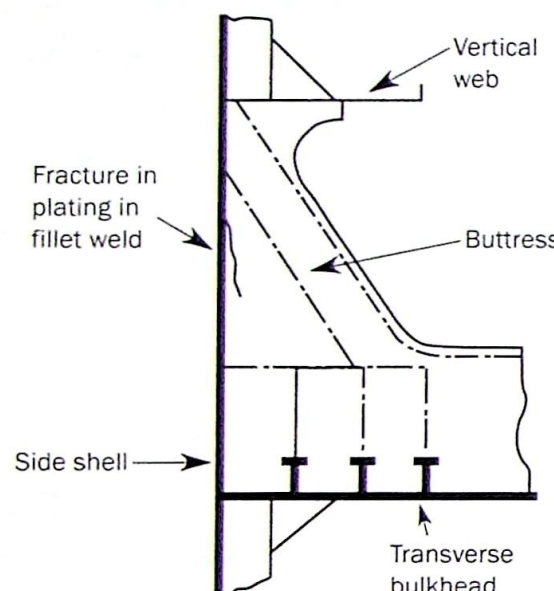
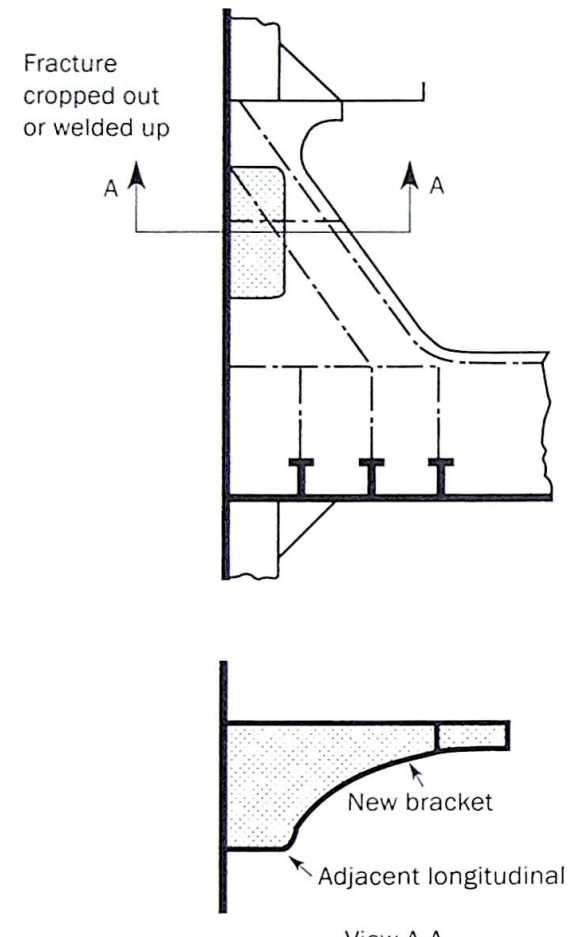
<p>GROUP No. 10 (Refer to index on Page 181)</p>	<p>Location: Transverse Bulkhead Horizontal Stringer</p>	
<p>Example No. 5: Fractured Web of Buttress at Connection to Shell</p>		
<p>Typical Damage</p>		<p>Proposed Repair</p>

<p>FACTORS CONTRIBUTING TO DAMAGE</p> <ol style="list-style-type: none"> Vibration of stringer web. 		
<p style="text-align: center;">Additional Notes</p>		
<ol style="list-style-type: none"> REPAIR NOTES <ol style="list-style-type: none"> Fractured area should be cropped and part renewed and an insert fitted. Small fractures can be repaired by welding. Additional bracket should be fitted to improve vibration stability of the buttress. ALTERNATIVE REPAIRS <ol style="list-style-type: none"> None known. UNSUCCESSFUL REPAIRS <ol style="list-style-type: none"> Web cropped out and insert fitted without reinforcement. NEW CONSTRUCTION <ol style="list-style-type: none"> Fit adequate panel stiffening where vibration may be anticipated.
