Guidance Manual for Tanker Structures

Consolidated Edition 2022

Tanker Structure Co-operative Forum

Consolidated text of 'Guidance Manual for Tanker Structures' incorporating IACS Recommendation No. 72: Confined Space Safe Practice – Rev.3 Dec 2018 and IACS Unified Requirements (UR) Survey and Certification: Z10.4 Hull Surveys of Double Hull Oil Tankers (Rev.16 May 2019).

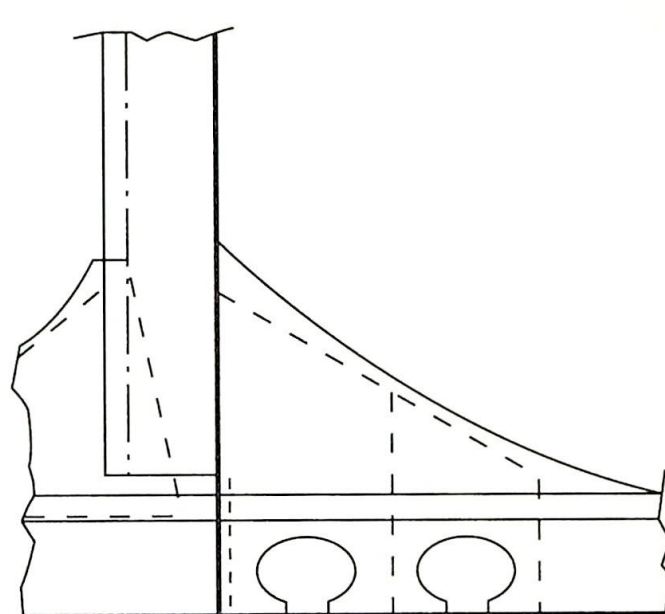
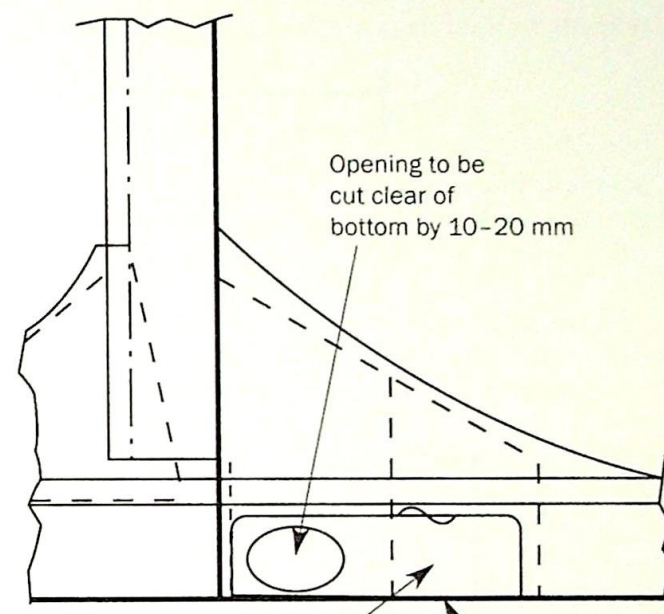
<p>GROUP No. 14 (Refer to index on Page 182)</p>	<p>Location: Miscellaneous Example No. 3: Fractures in Bottom Plating in Way of Drainage Openings</p>	
<p>Typical Damage</p>		<p>Proposed Repair</p>

<p>Crack in bottom plating</p>

<p>Opening to be cut clear of bottom by 10-20 mm</p> <p>Insert web with reduced opening</p> <p>Insert in bottom plate</p>
<p>FACTORS CONTRIBUTING TO DAMAGE</p> <ol style="list-style-type: none"> 1. Large opening area compared with longitudinal height, not compensated by bracket. 2. High stress concentration. 3. Localized corrosion/erosion at area of stress concentration. 		
<p>Figure 69: 4 of 5</p>	<p>Catalogue of Structural Details</p>

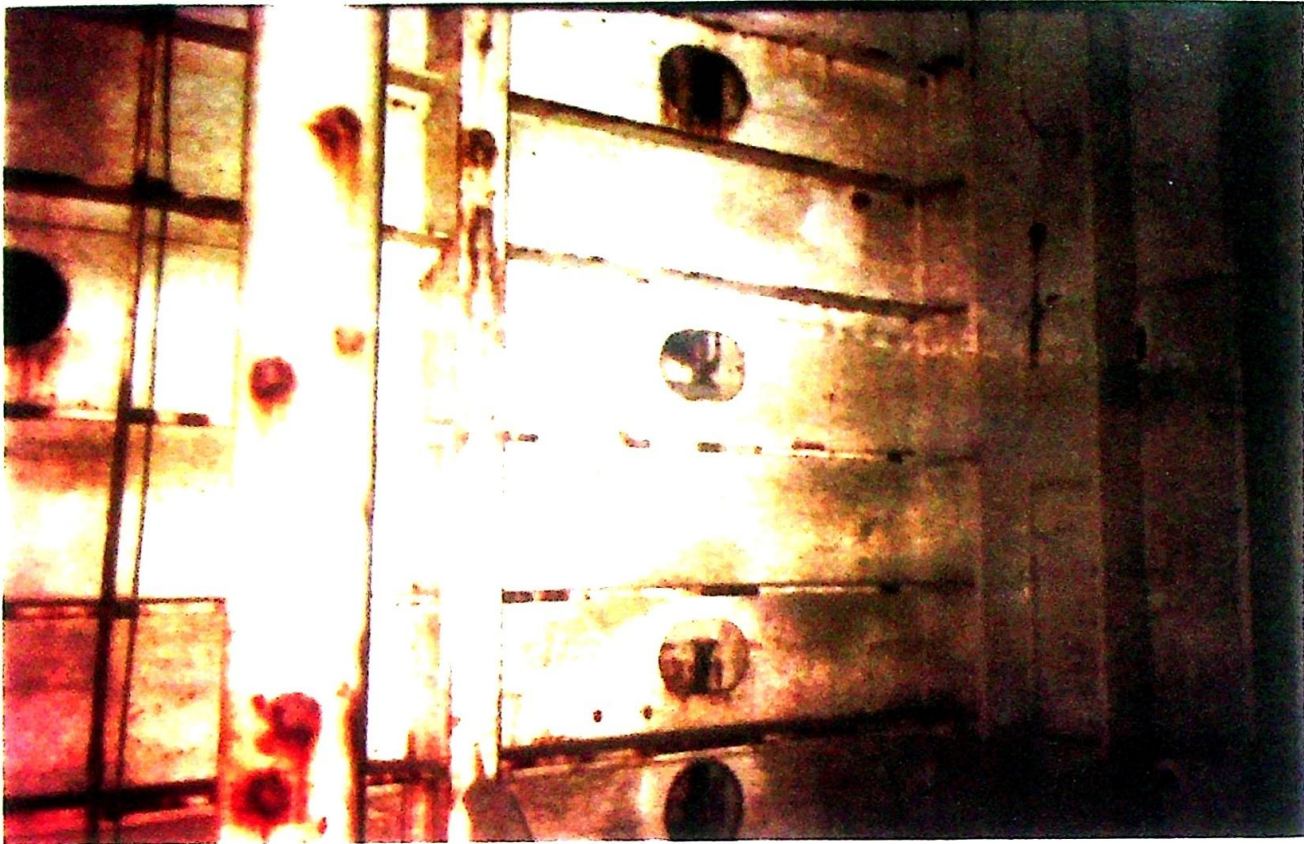
Figure VII.3: Coating Condition Evaluation

CONDITION: 1. GOOD

REMARKS: Lower end of GOOD

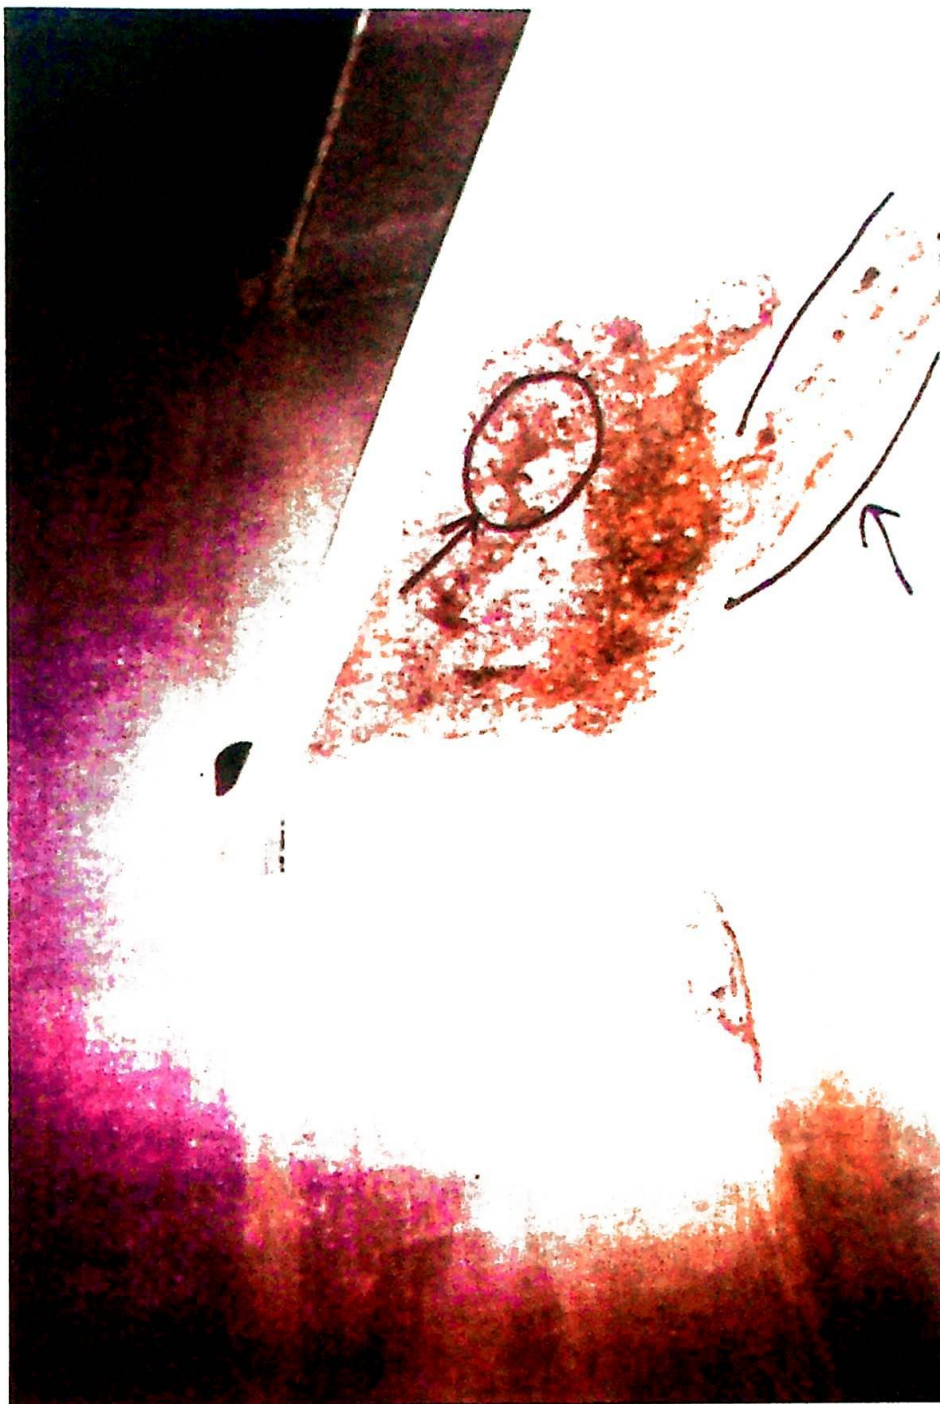
Figure VII.4: Coating Condition Evaluation

0.1%

1%

REMARKS: Local corrosion problem which must be dealt with, however, considered not to reflect the general coating condition

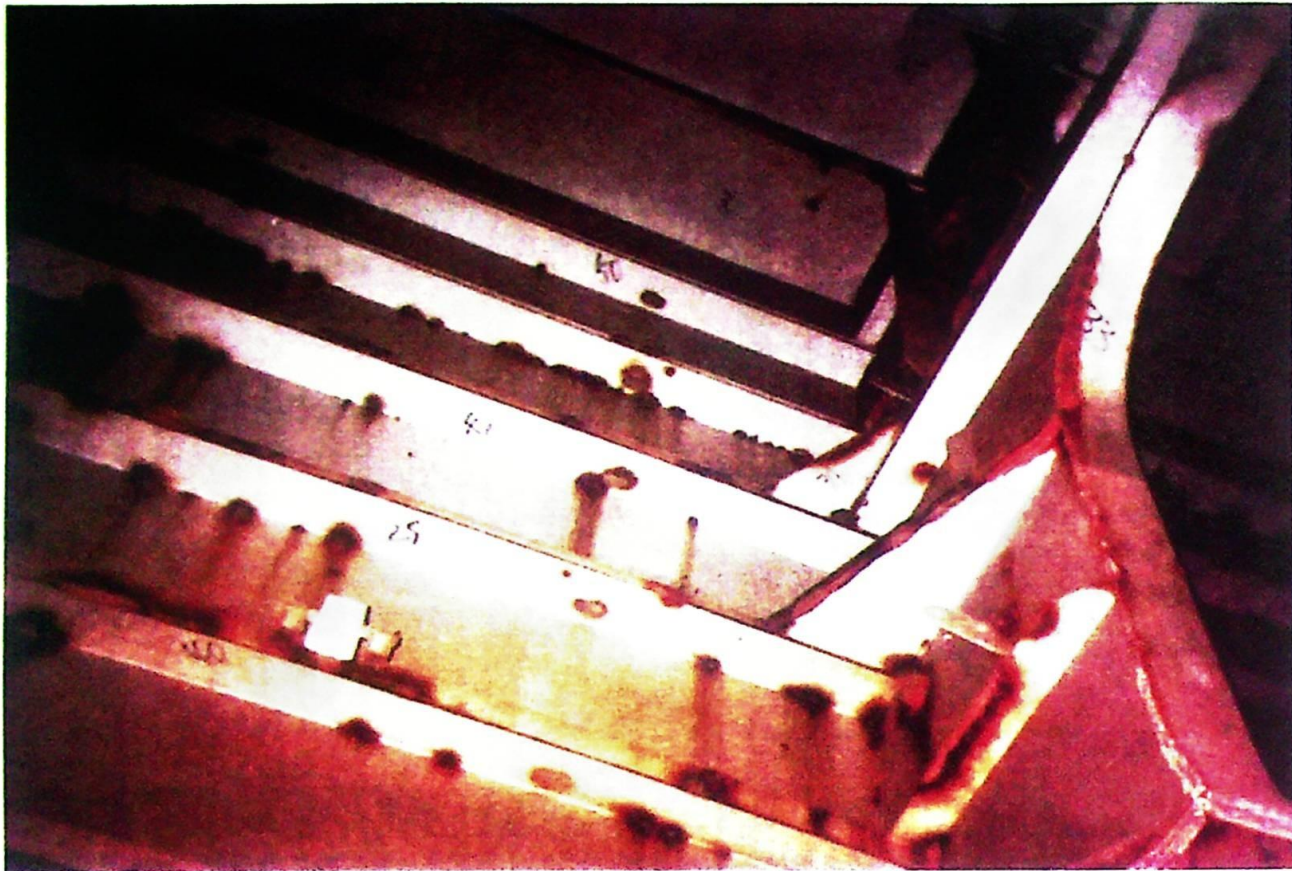
Figure VII.5: Coating Condition Evaluation

CONDITION: 2. FAIR

REMARKS: Upper end of FAIR

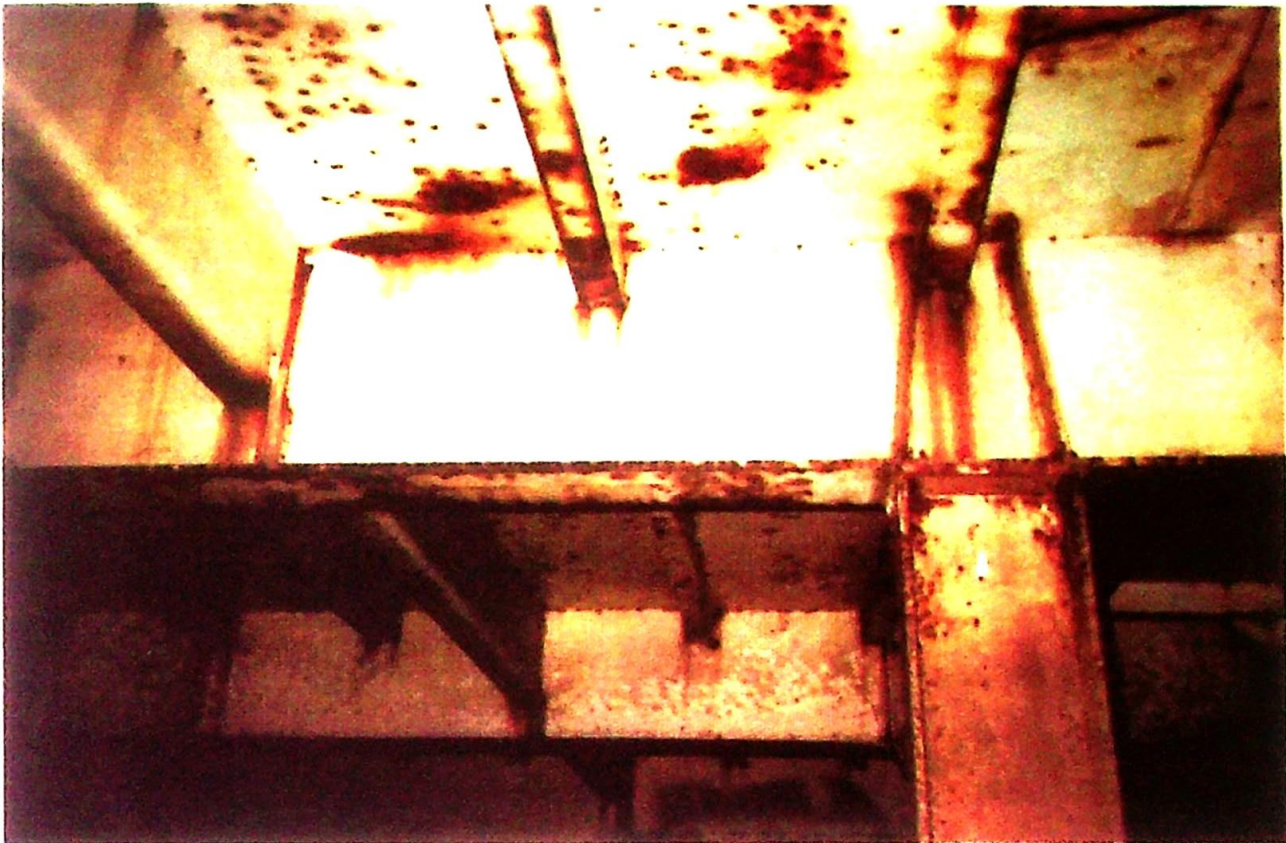
Figure VII.6: Coating Condition Evaluation

CONDITION: 2. FAIR

REMARKS: Typical FAIR Condition

5%

10%

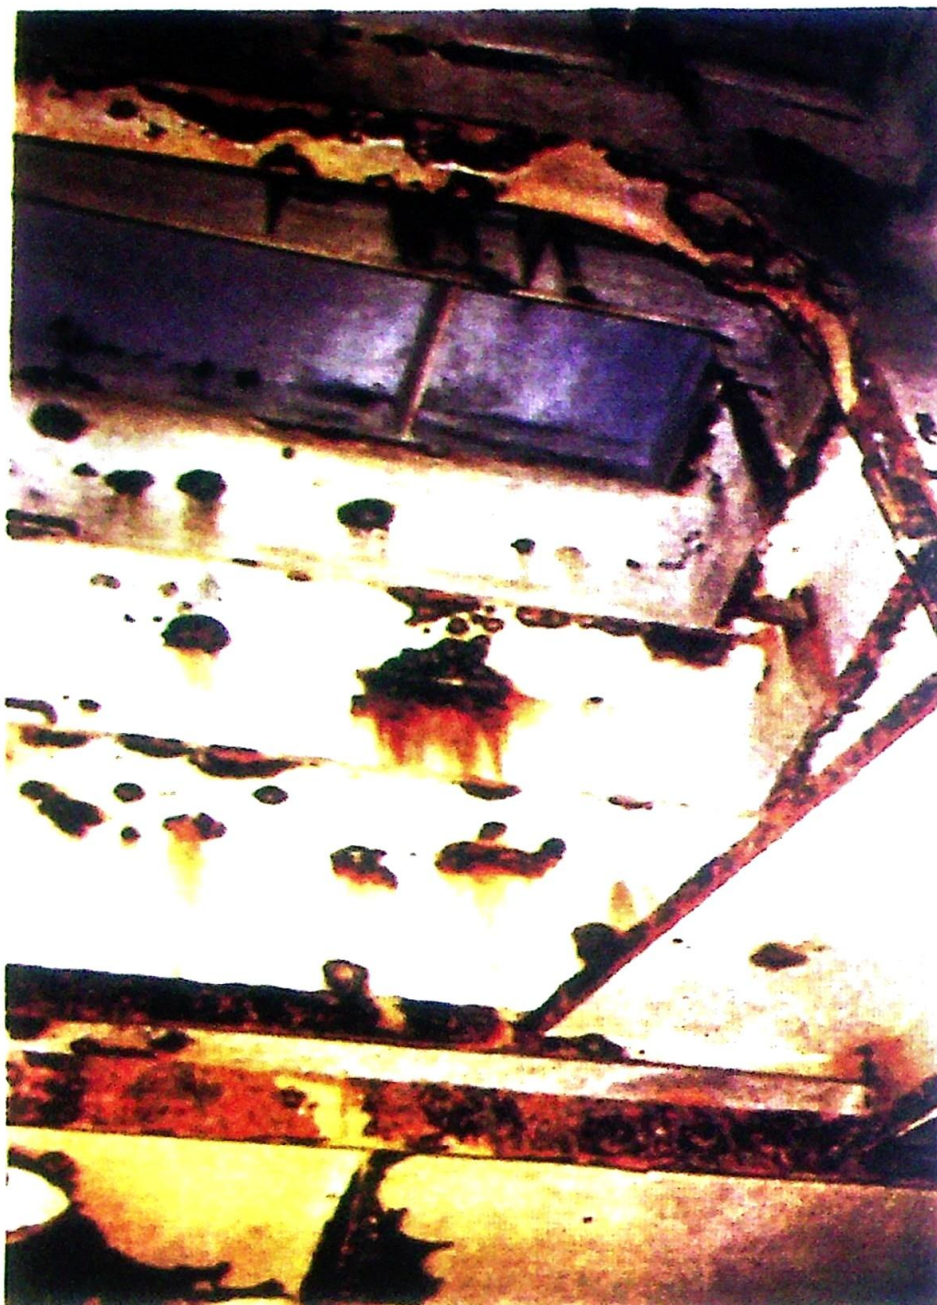
Figure VII.7: Coating Condition Evaluation

10%

25%

REMARKS: Lower end of FAIR. Condition of upper side of horizontal surface should be included in the evaluation before final condition is determined.

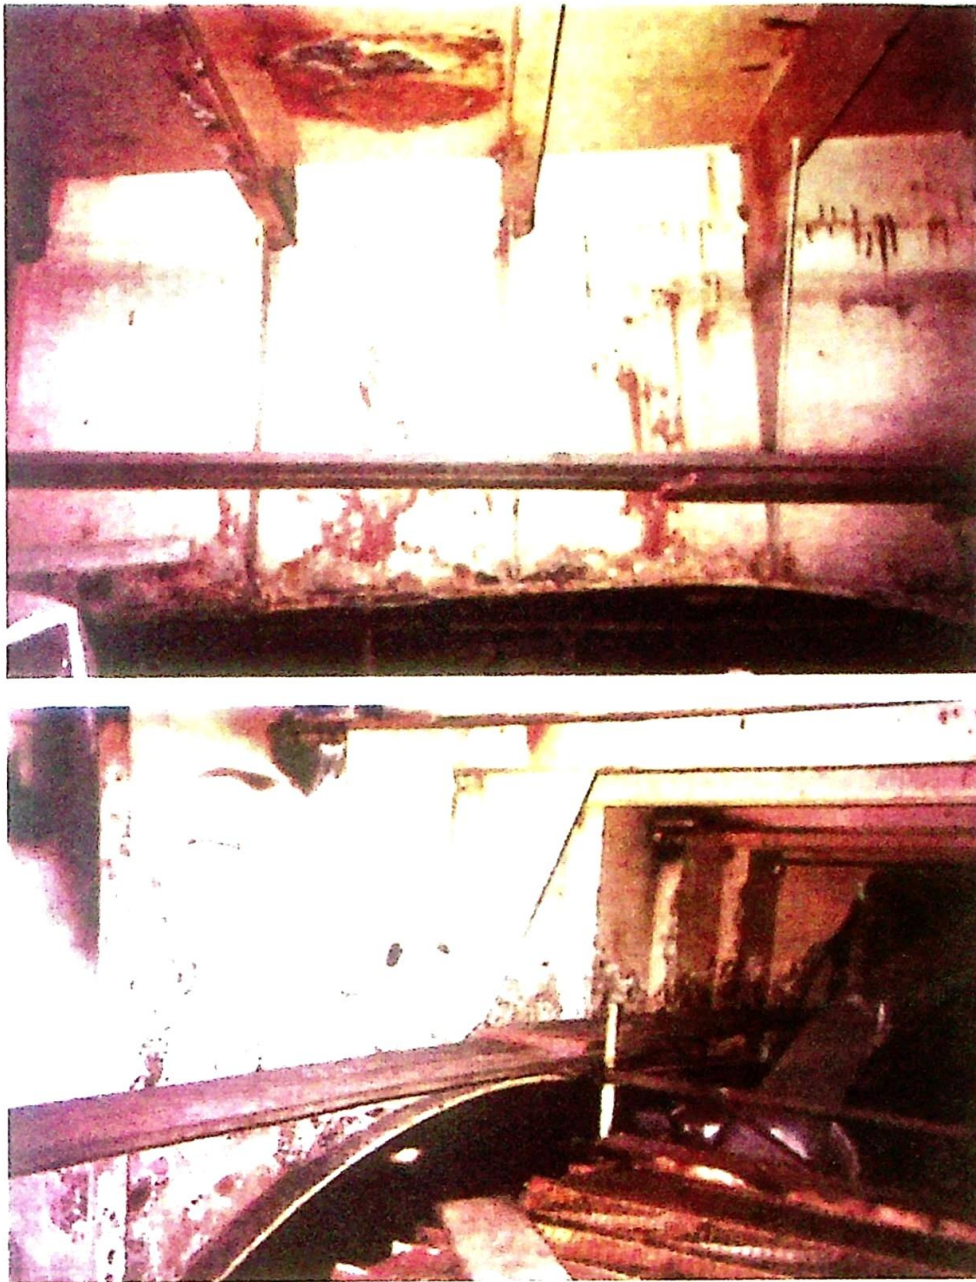
CONDITION: 2. FAIR

REMARKS: - Lower end of FAIR
- Condition shown after descaling

10%

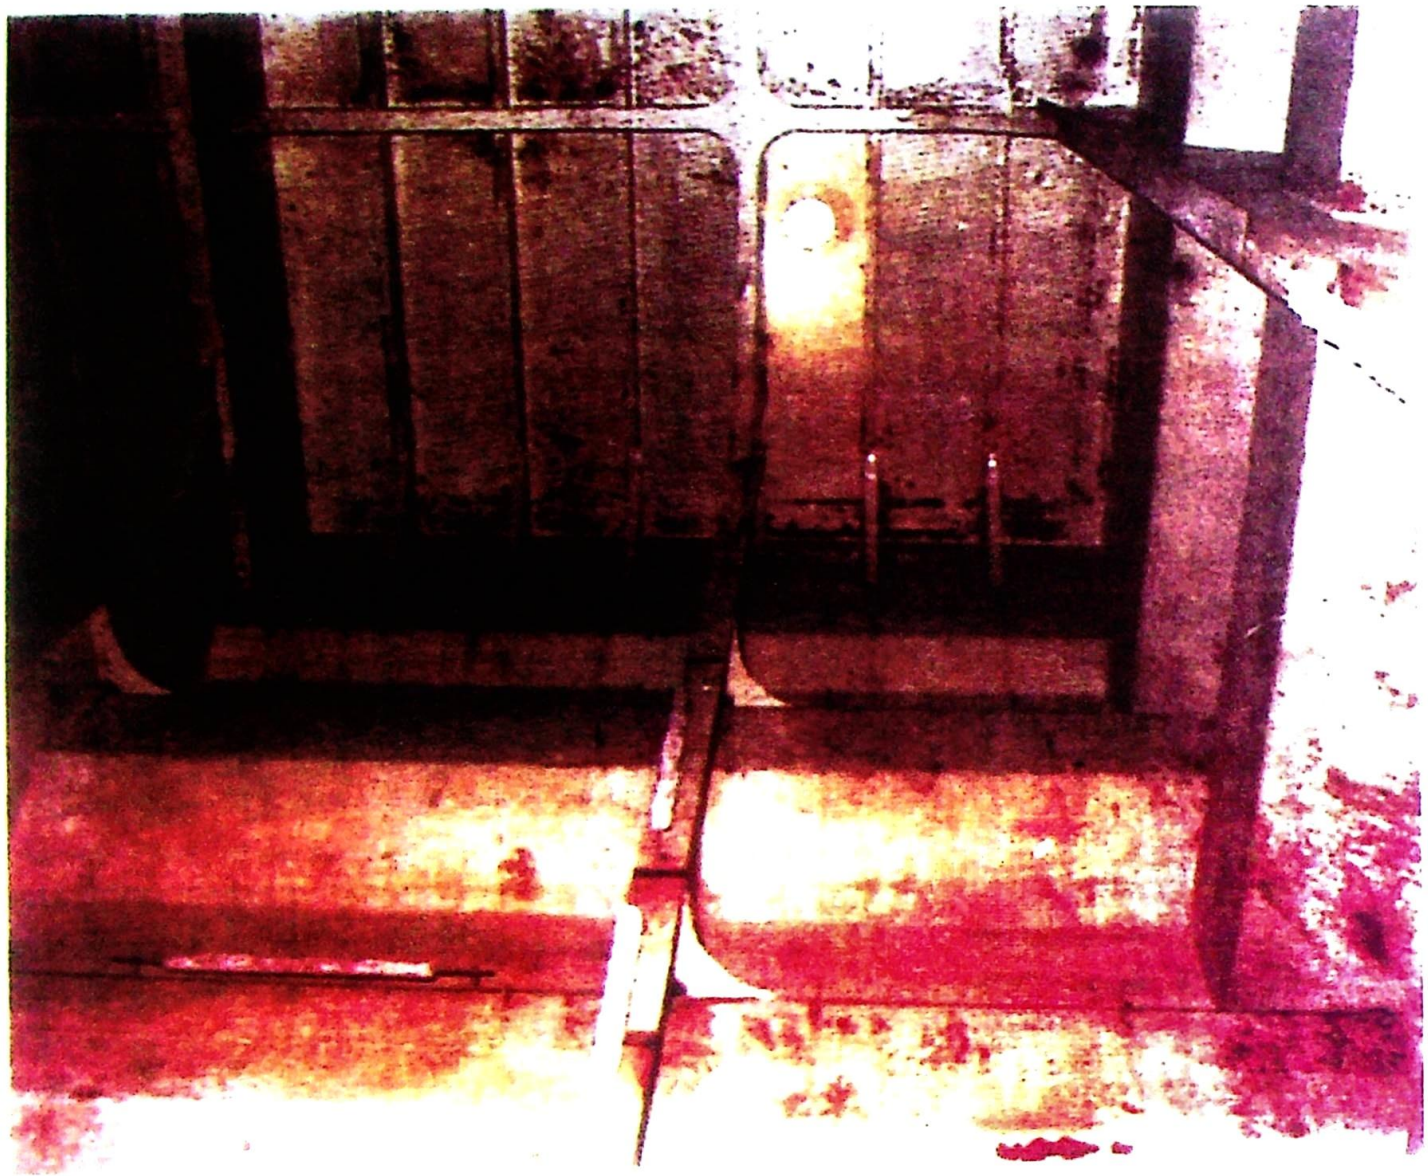
Figure VII.9: Coating Condition Evaluation

CONDITION: 2. FAIR

BREAKDOWN
PERCENTAGE: Light rusting over 5% of area

An 'Assessment Scale for Breakdown' of coatings is shown in Figure VII.1. Examples of coating system condition categorised under the above rating system are shown in the following paragraphs (Figures VII.2 to VII.15).

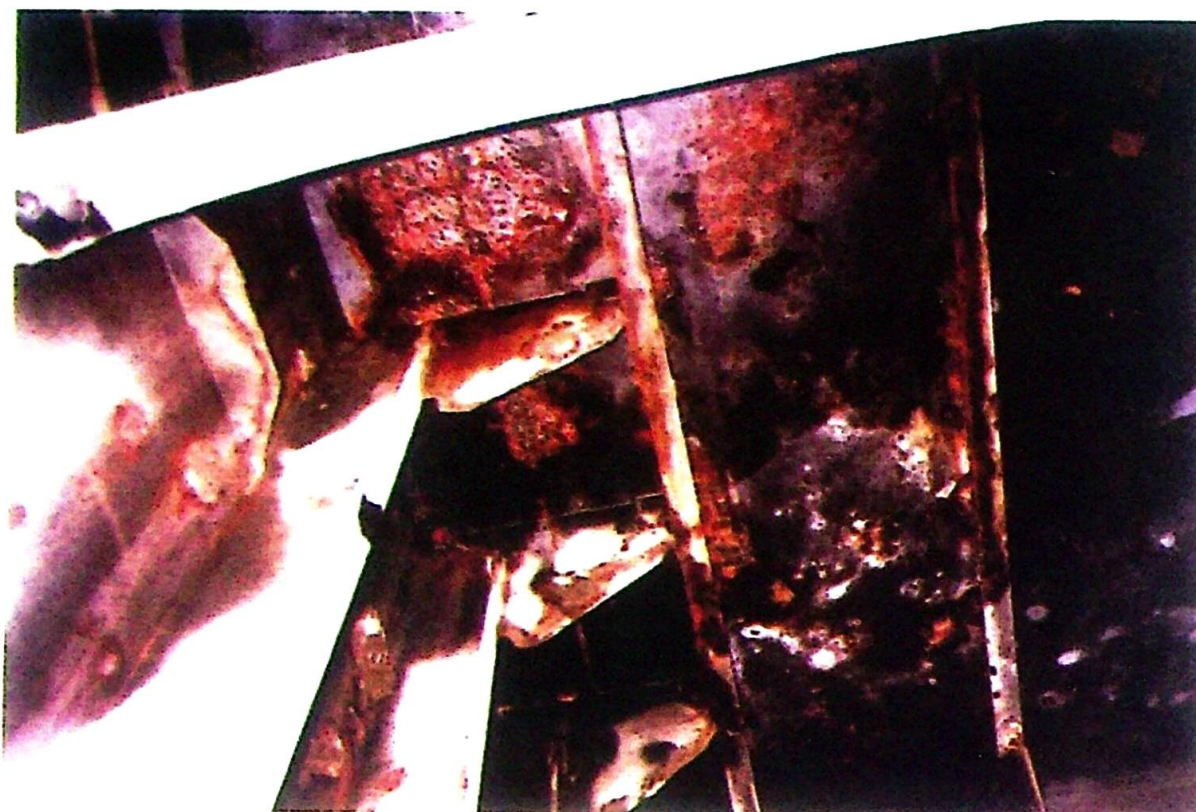
Figure VII.11: Coating Condition Evaluation

CONDITION: 3. GOOD

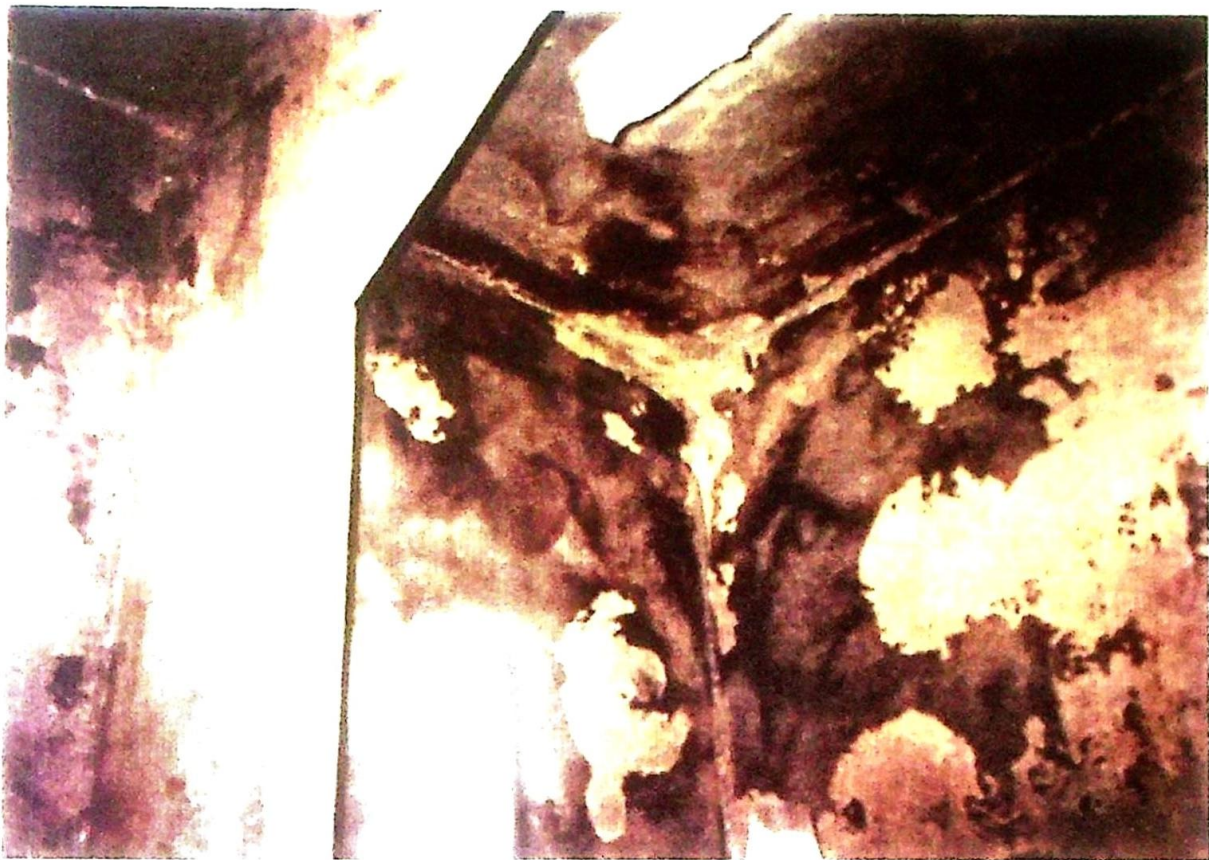
Figure VII.14: Coating Condition Evaluation

CONDITION: 3. POOR

REMARKS: POOR Condition of Coating.
(Picture taken after cleaning.)

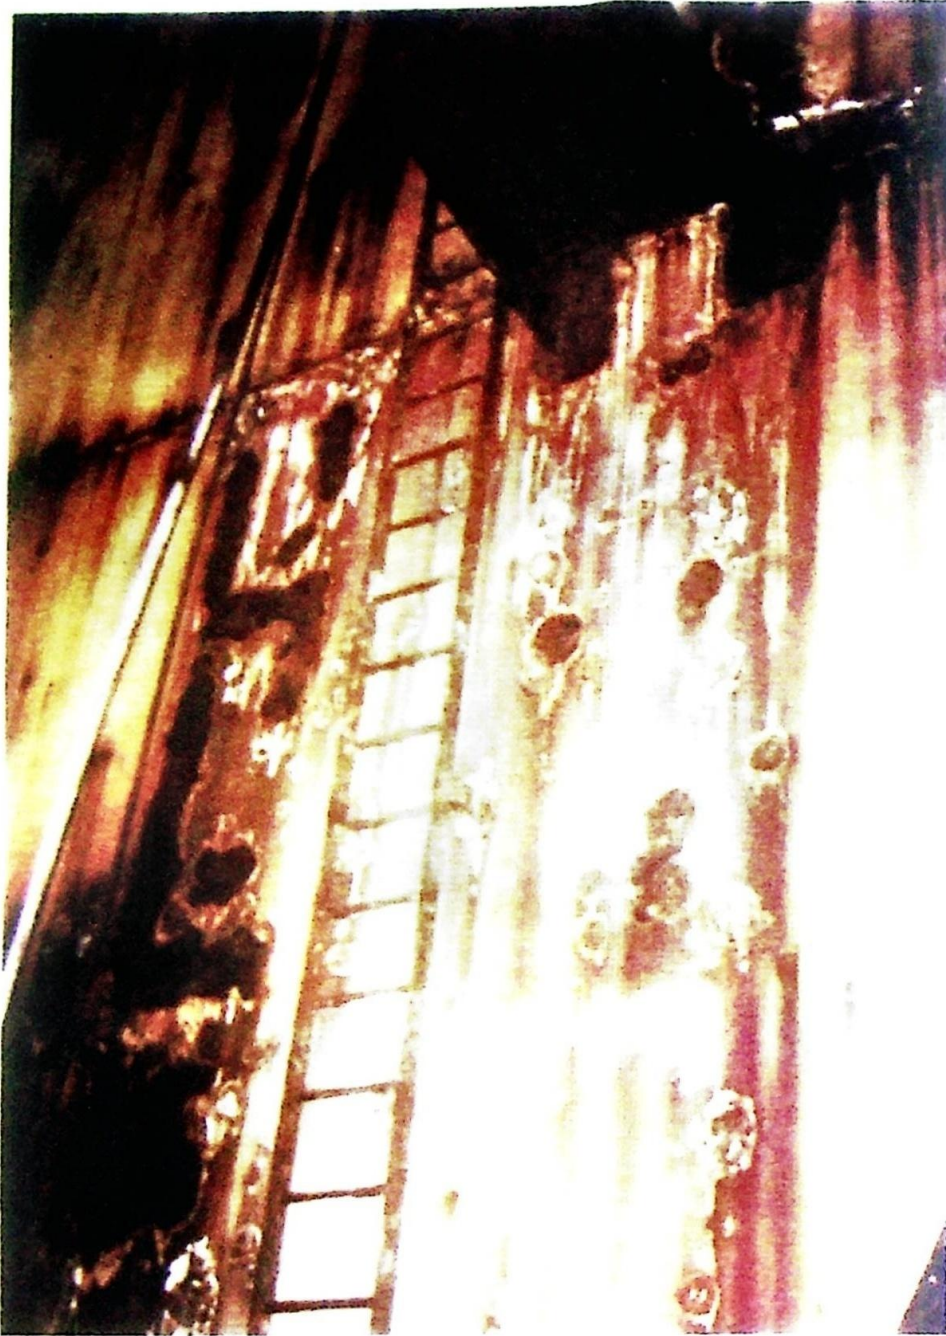
Figure VII.15: Coating Condition Evaluation

CONDITION: 3. POOR
